# Injection-Molding Problems in Engineering Thermoplastics

## Causes and Solutions

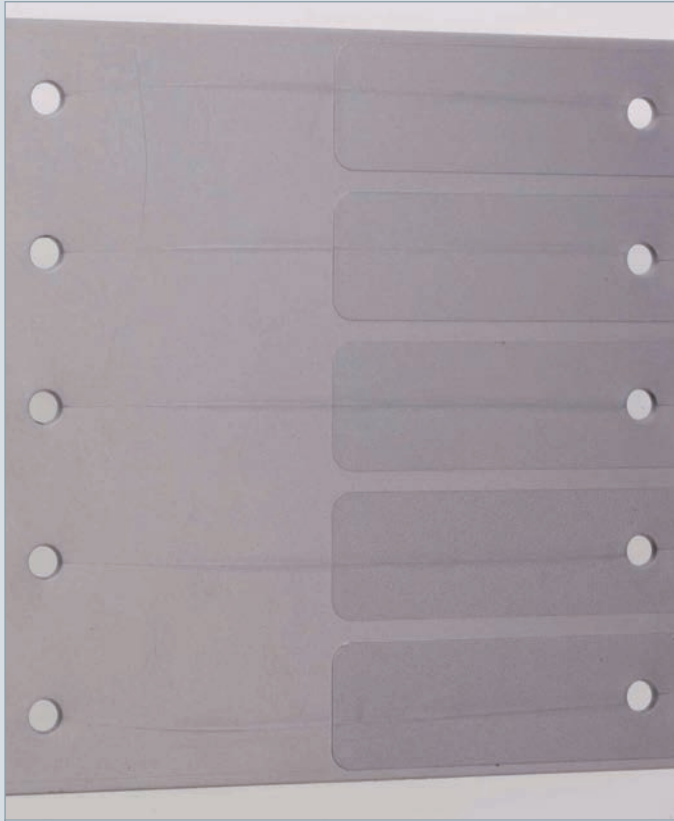
Weld lines after holes

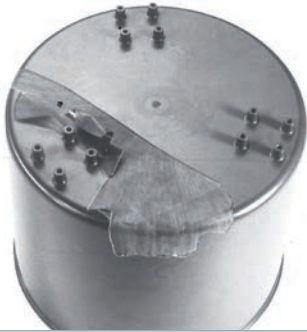
Delamination caused by an injection speed that is too high (mineral-filled Ultramid®)

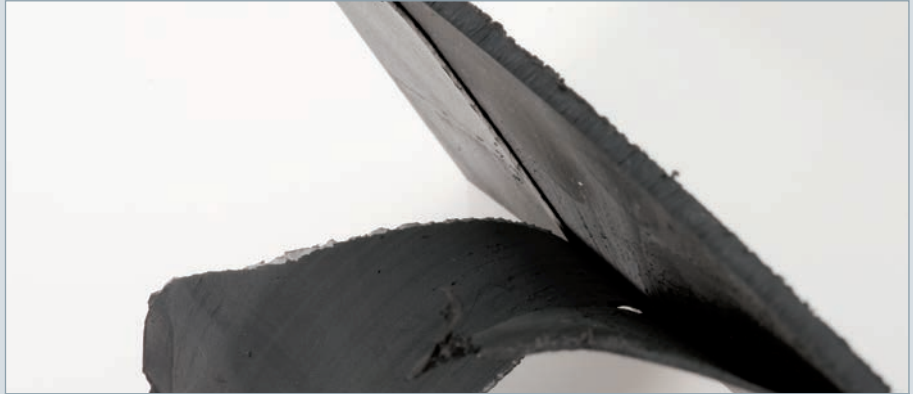
Delamination due to an injection speed that is too high (Ultramid T)

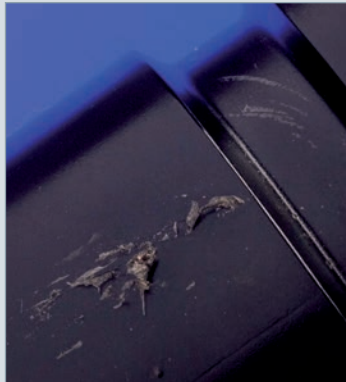
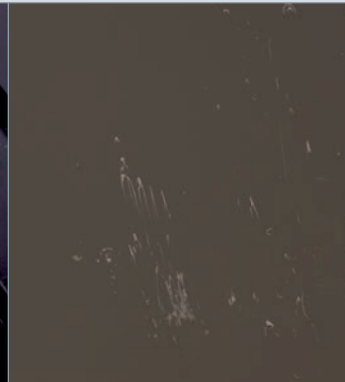
Delamination caused by entrapped air during metering (unreinforced Ultramid)

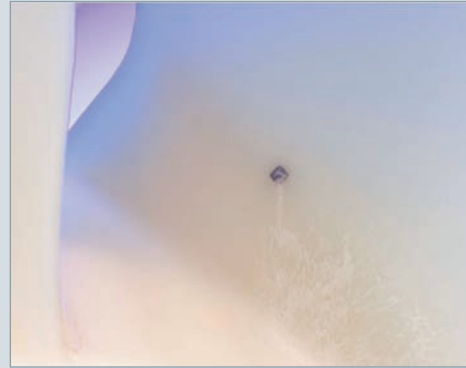
Black specks  
caused by  
foreign granules

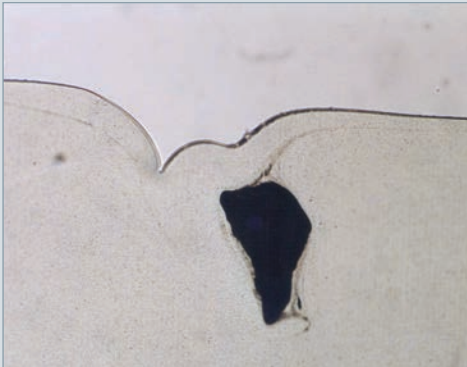
Deposits from a  
hot runner following  
a standstill of the  
machine (Ultrason)

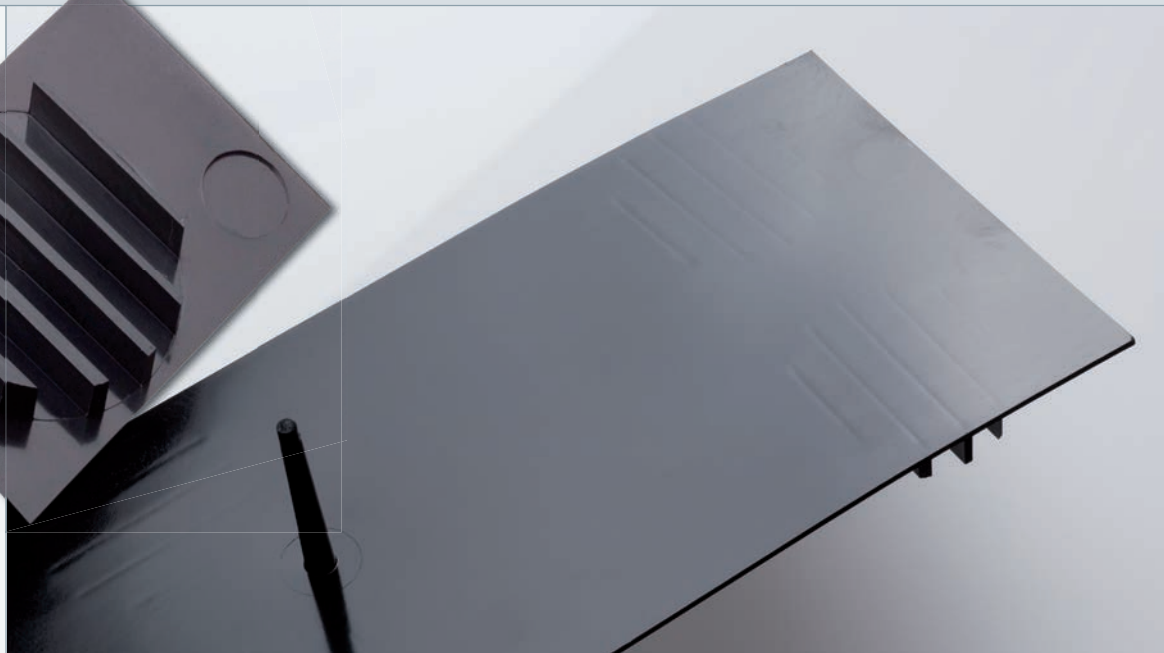
Sink marks caused  
by ribs (glassfiber-  
reinforced Ultramid®)

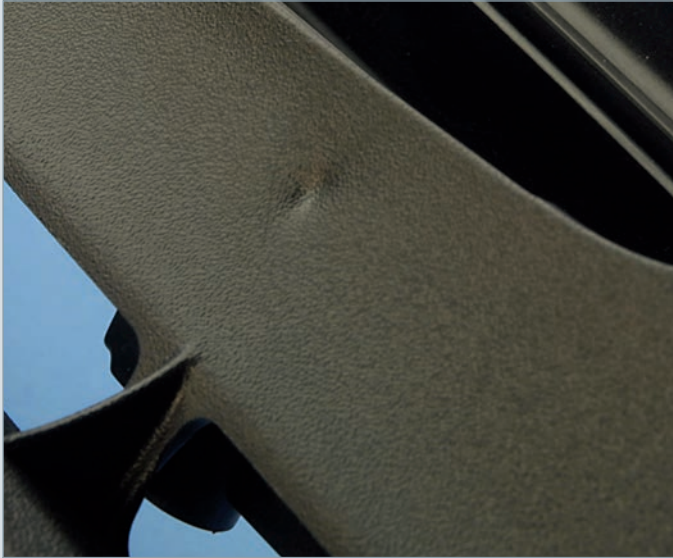
Sink mark in a section with an increase of wall thickness: the design of the screw-in mandrel is not appropriate for processing this plastic

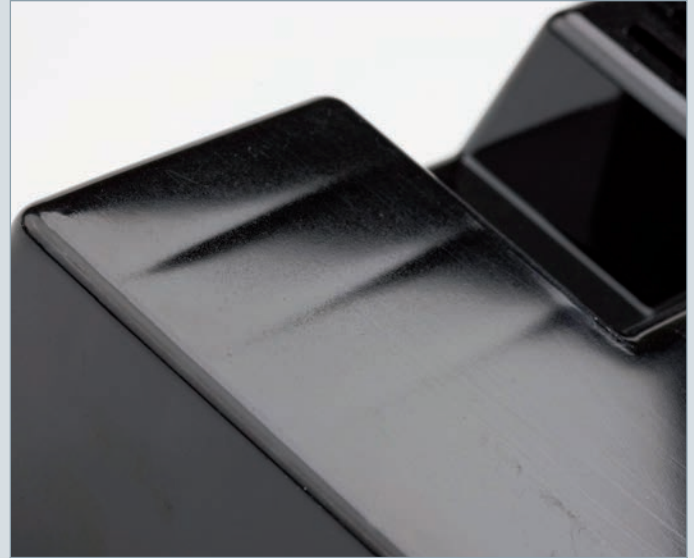
Sink marks caused by ribs

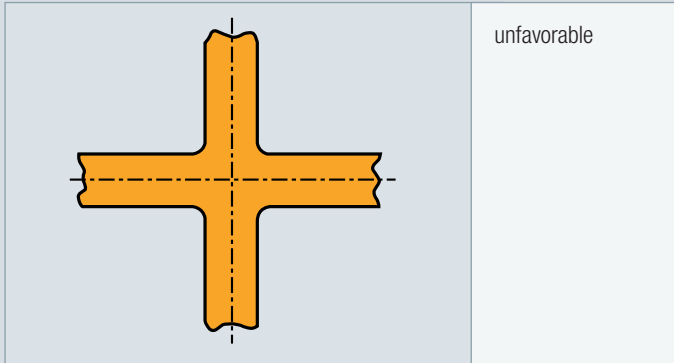
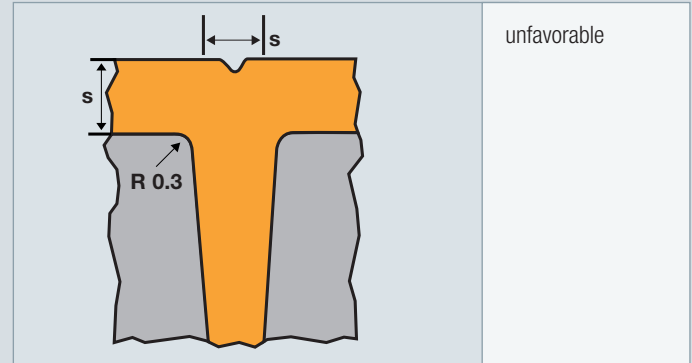
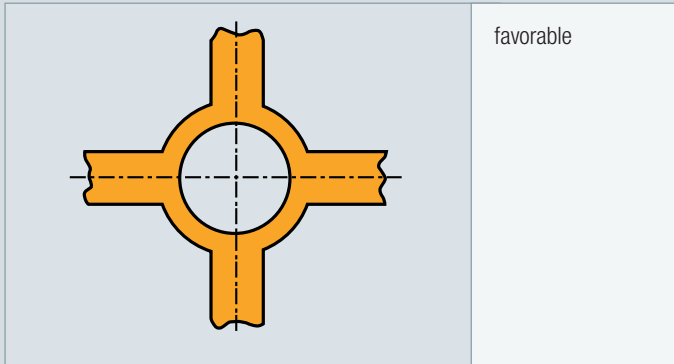
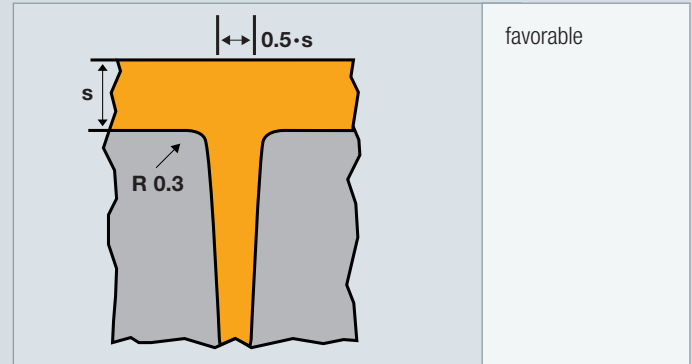
Avoiding sink marks (voids) by designing the rib connection so as to be appropriate for processing this plastic

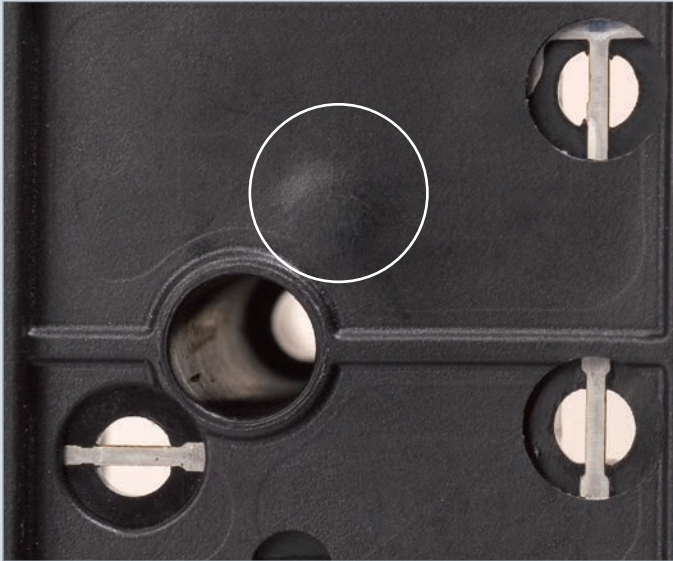
Ejector markings caused by the cooling time being too short

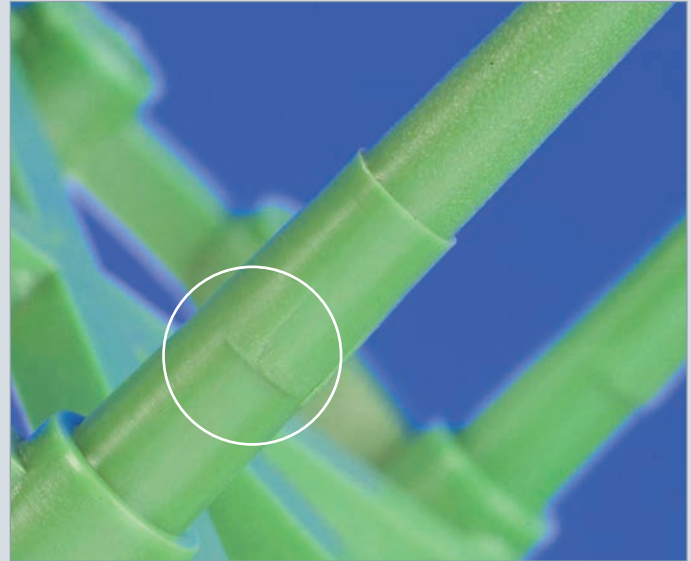
The sprue gets stuck to the cavity plate because of an undercut.

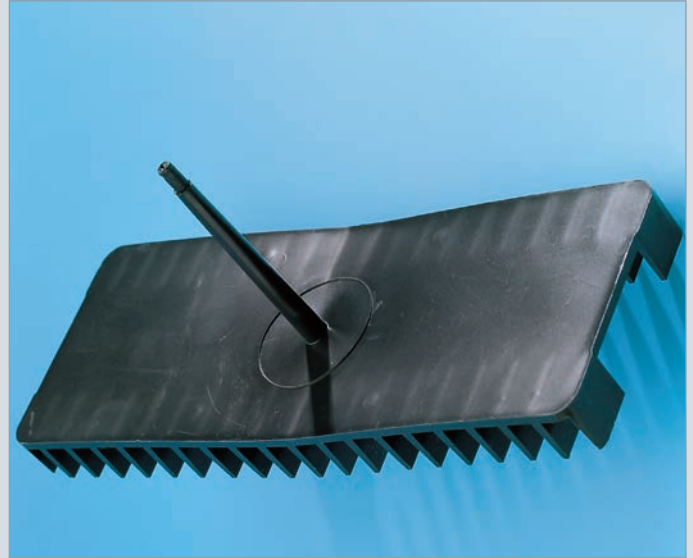
Mold-removal problems caused by overpacking (holding pressure is too high)

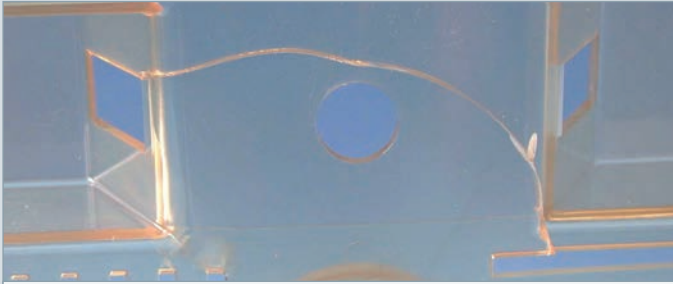
Corner with a sharp edge

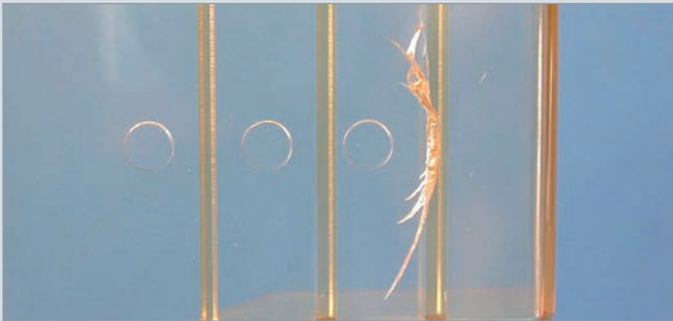
Rib without draft, asymmetrical arrangement of the ejectors

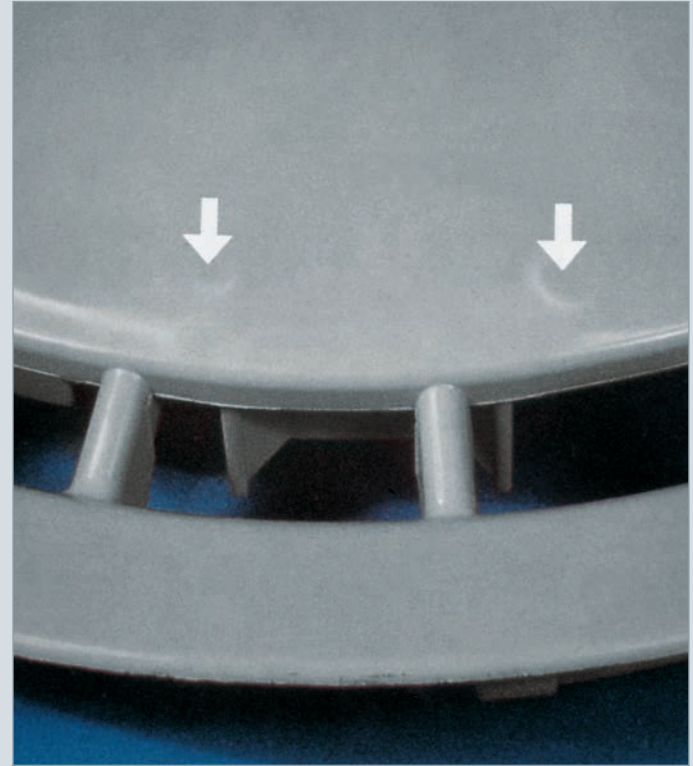
Ejector markings – remedied by increasing the ejector diameters

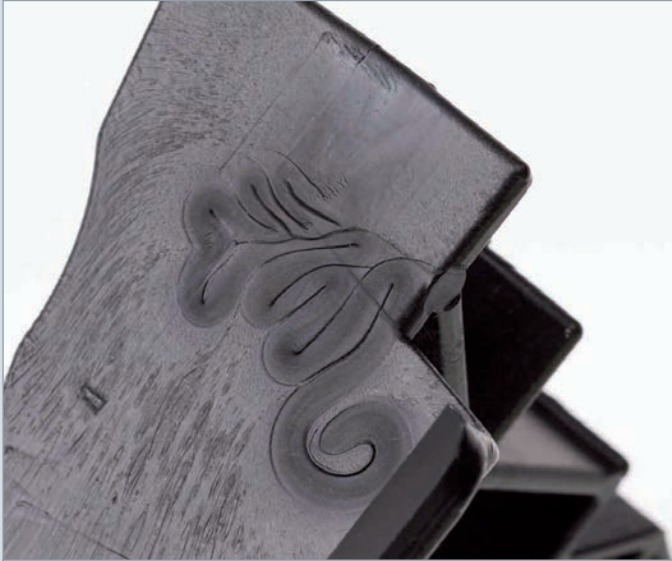
Jetting due to the unfavorable position of the gate

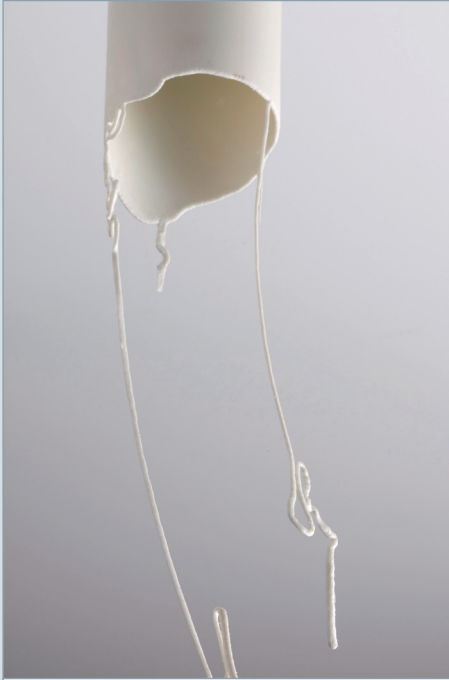
Jetting on a sleeve caused by three-fold gating through a pin gate

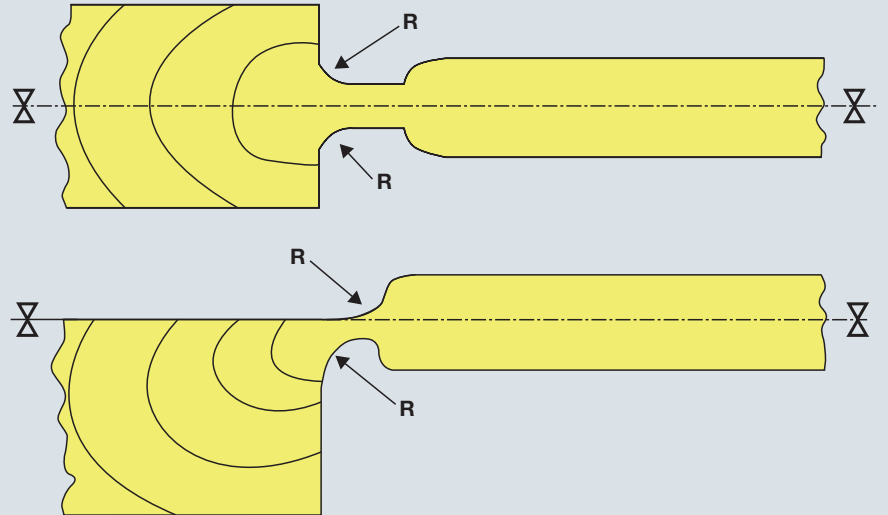
Ensure proper radii in the transition area from the gate to the molded part

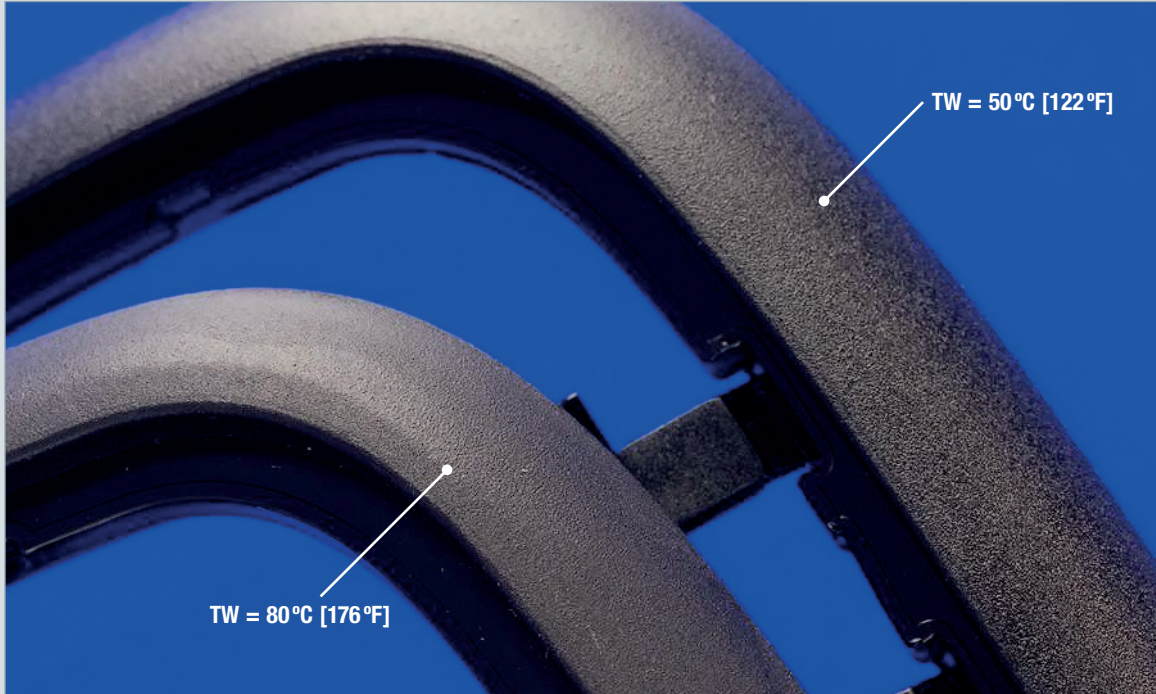
Influence of the mold temperature (TW) on the gloss (glassfiber-reinforced Ultramid®)

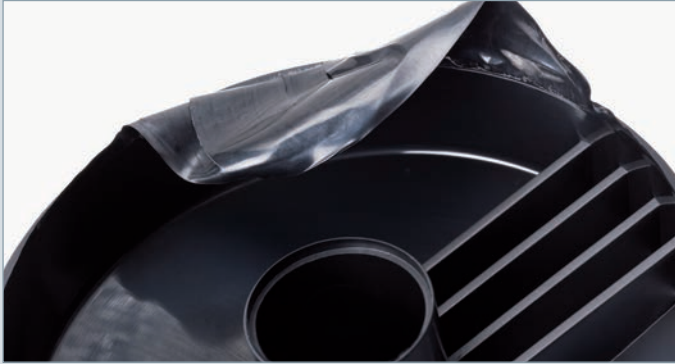
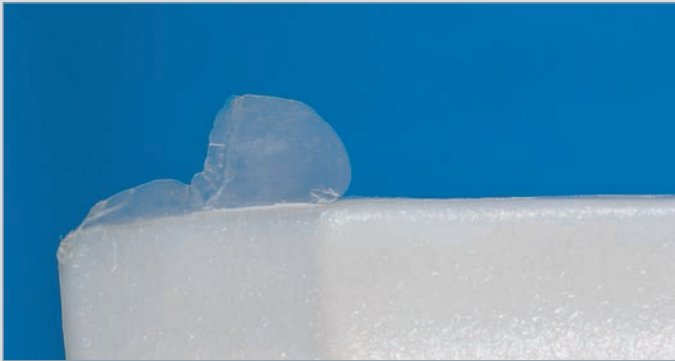
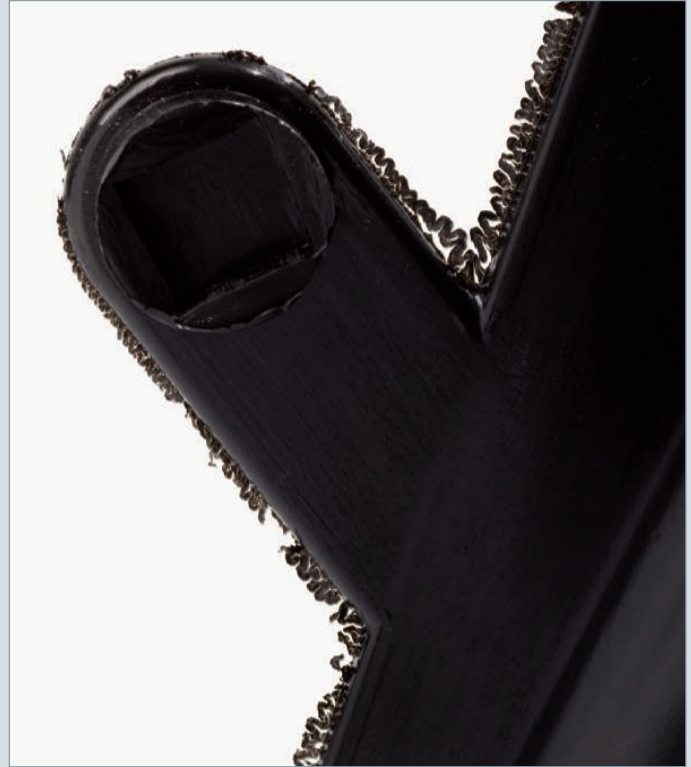
| Causes | Recommendations |
|---|---|
| The mold is deforming under filling pressure. | <ul style="list-style-type: none"> <li>• Strengthen the mold construction.</li> </ul> |

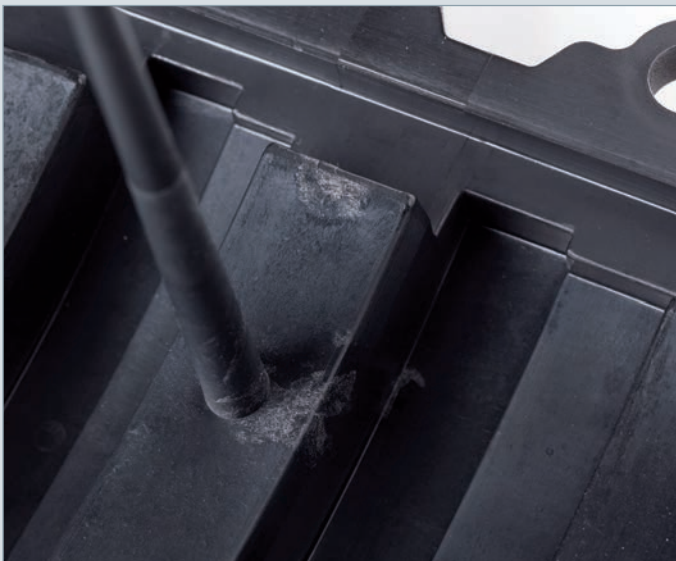
Cold slug from the bore of a machine nozzle that has cooled and broken off (glassfiber-reinforced Ultradur®)

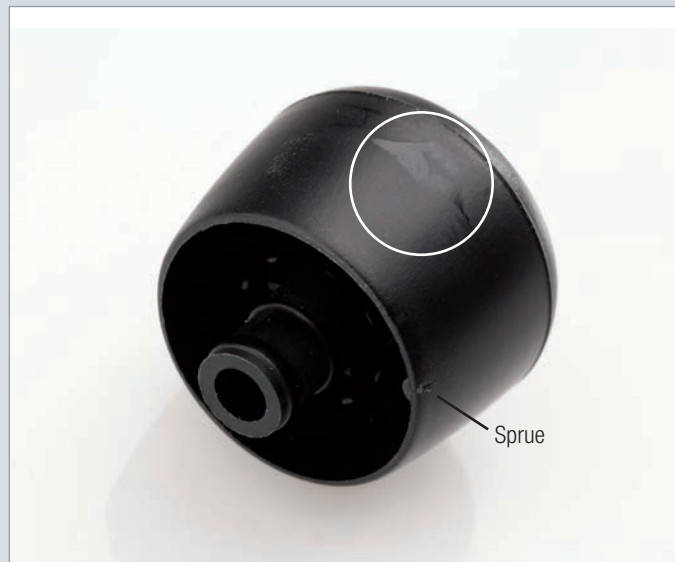
Cold slug in a molded part made of glassfiber-reinforced Ultramid®

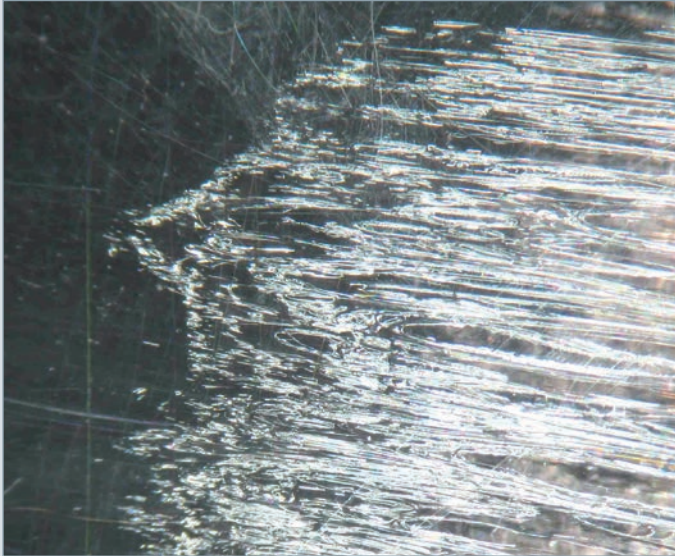
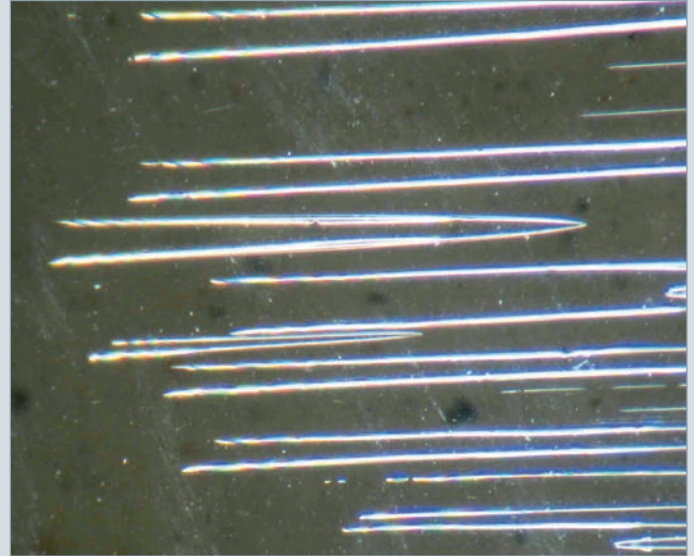
**Streaks in Ultrason® caused by cold slug**

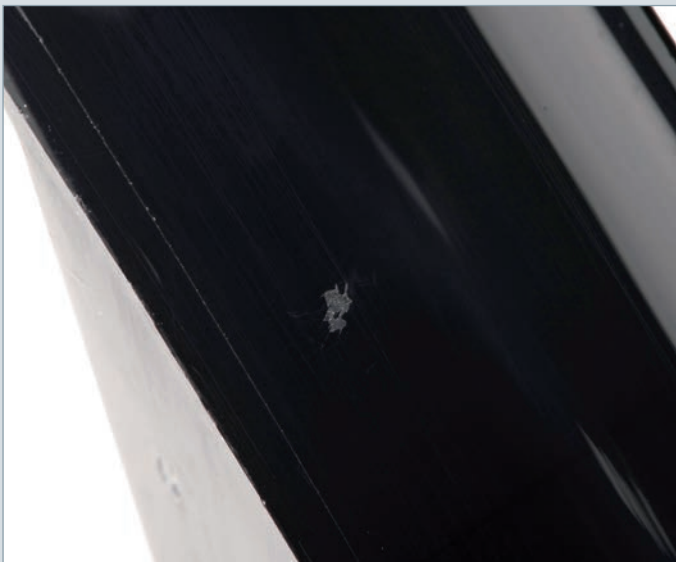
Surface blemish caused by a gate that has broken off (unreinforced Ultradur)

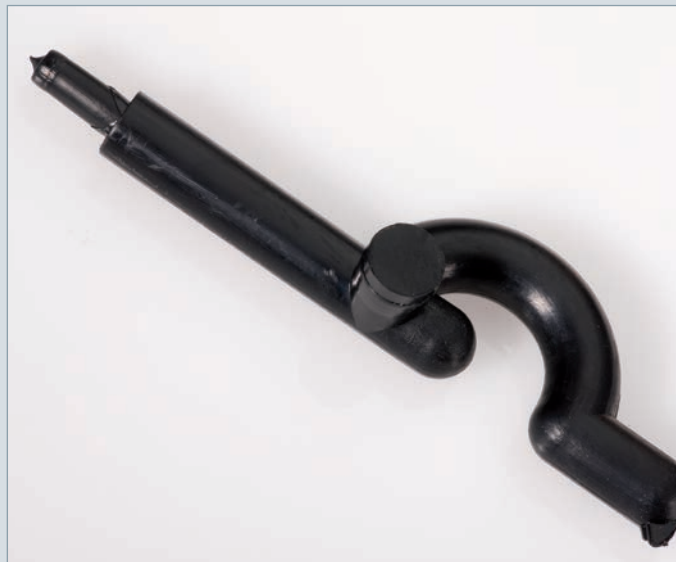
Cold slug catcher in a gate with a deflection in order to prevent jetting (injection through the parting surface)

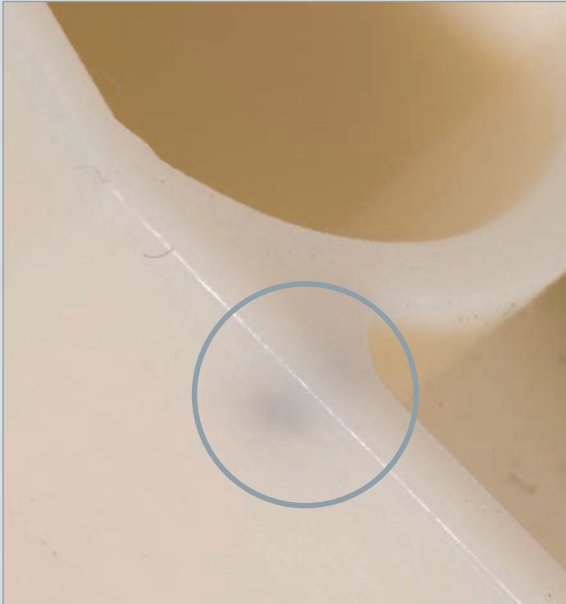
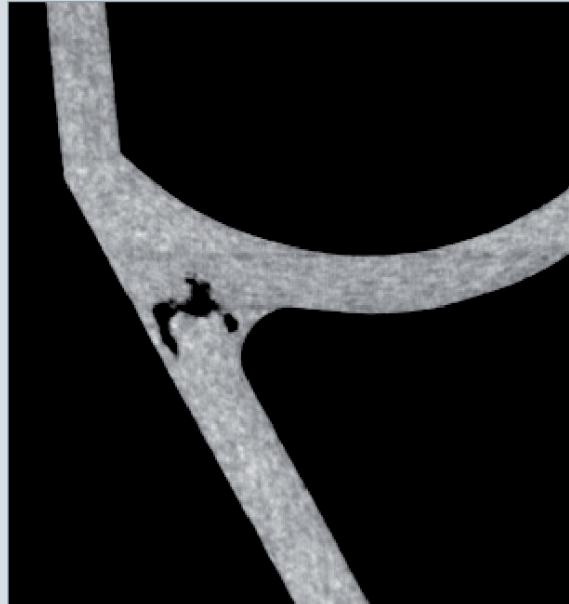
Image of a section of a molded part, taken by 3D computer tomography

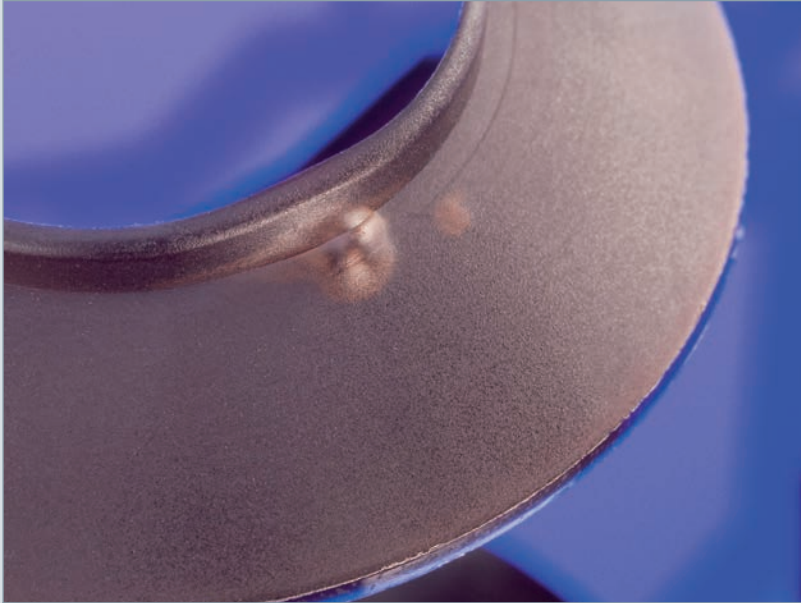
Air entrapment caused by entrapped air during the metering (unreinforced Ultramid®)

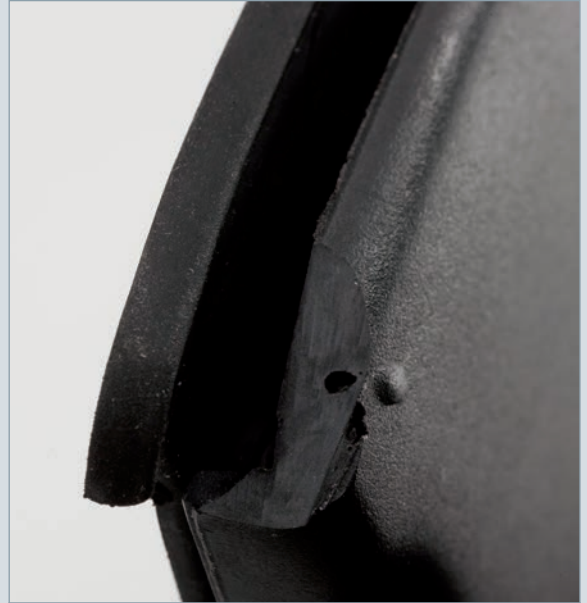
Air entrapment caused by an unfavorable molded part design

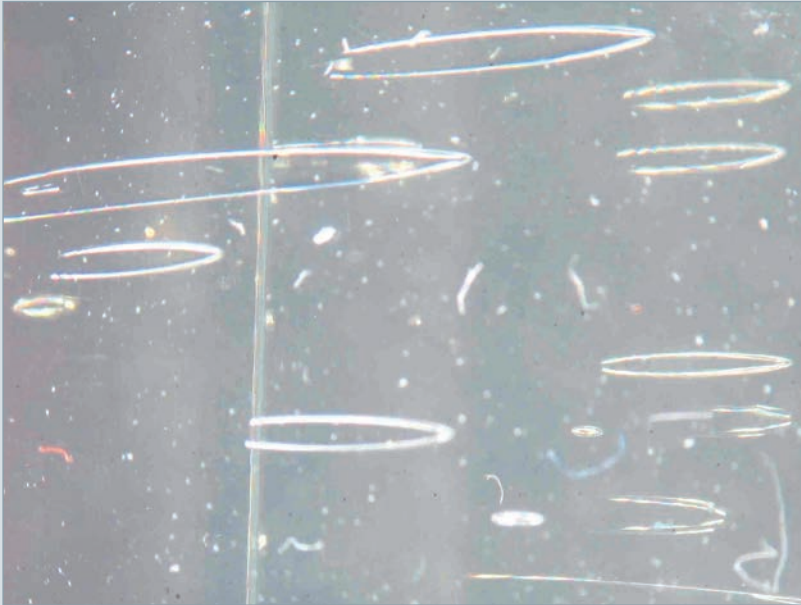
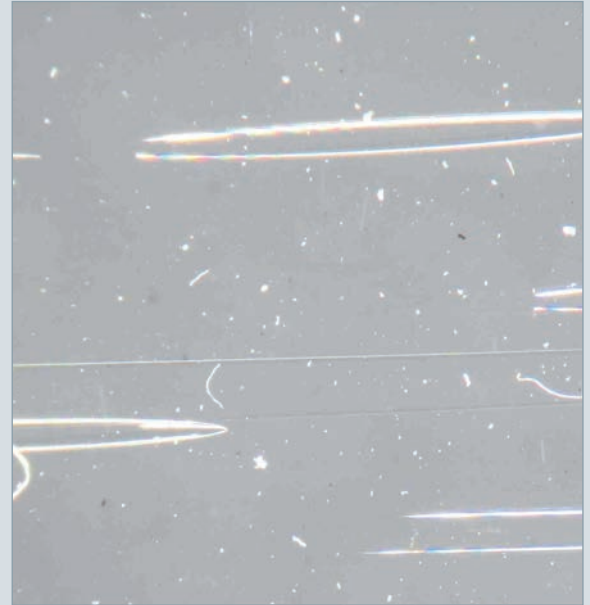
**Streaks caused by entrapped air (Ultrason®)**

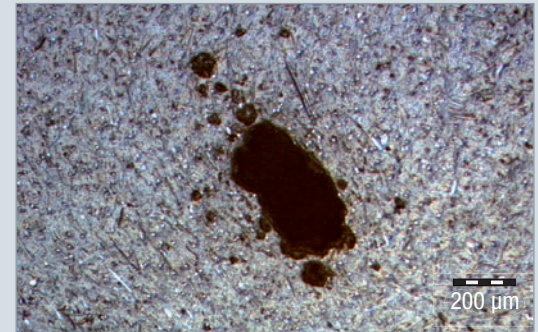
Detail from image above, polished section, optical light  
microscopic image with vertical illumination

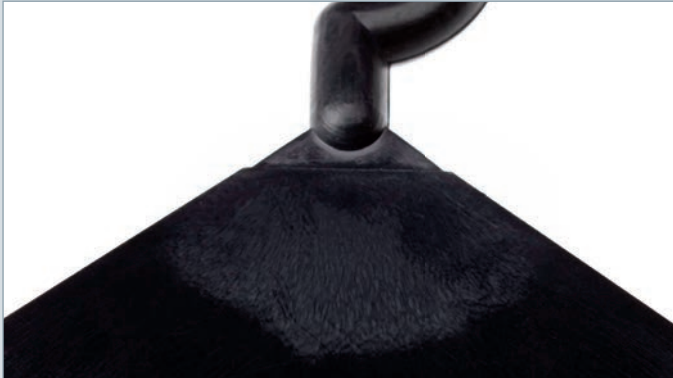
Dull spots caused by a cross section transition

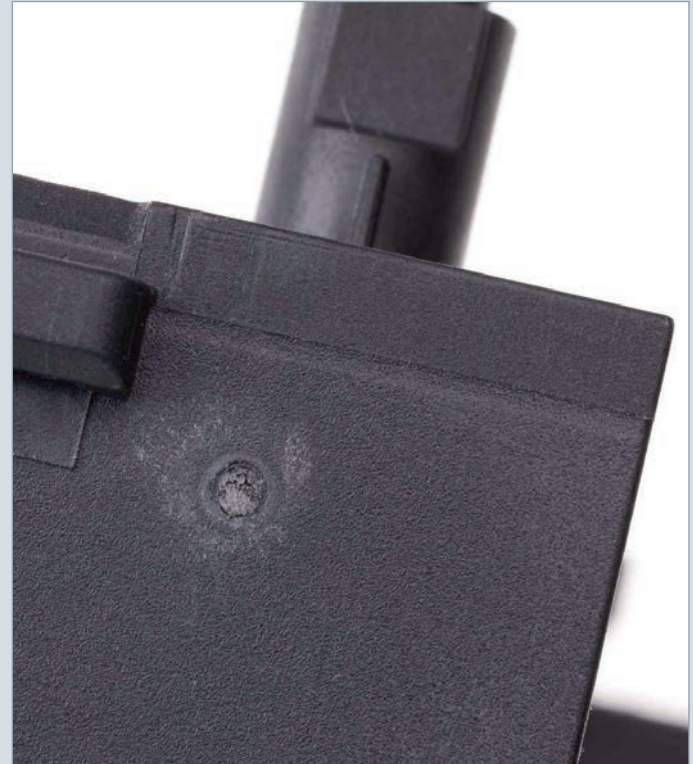
Dull spots in the area of the gate caused by high shear

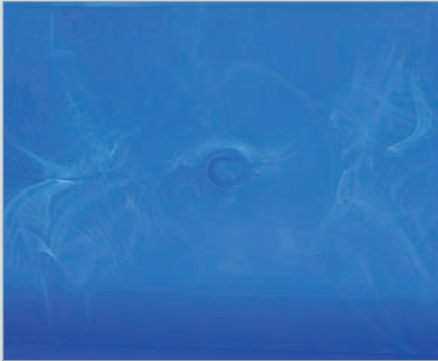
Colored streaks caused by the use of an unsuitable masterbatch

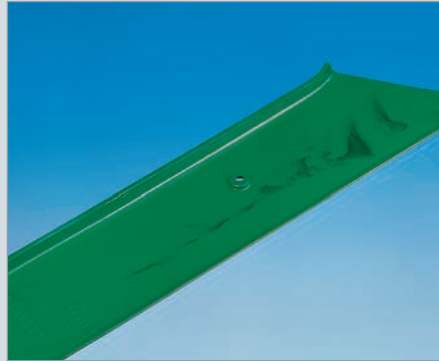
Colored streaks due to impurities in the hot runner

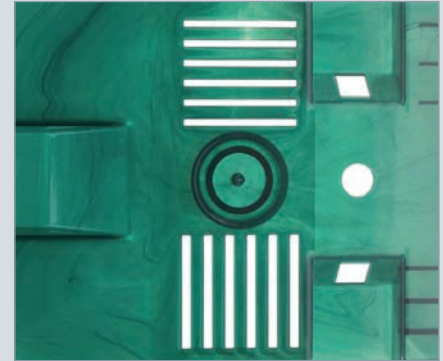
Colored streaks caused by the use of a screw with an unsuitable geometry

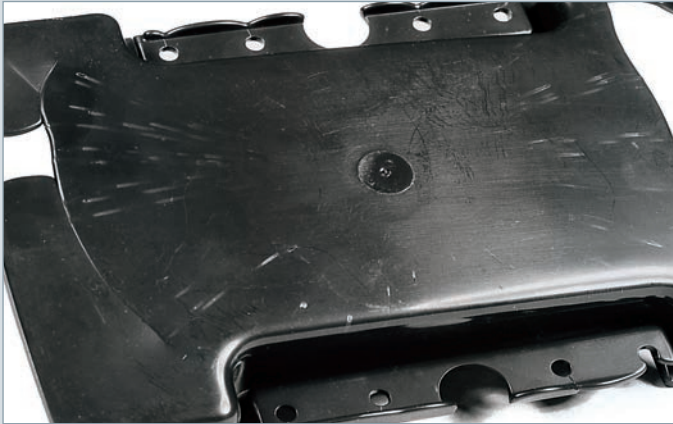
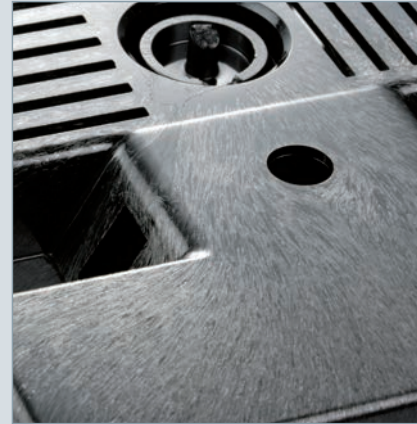
**Moisture streaks  
in Ultrason®**

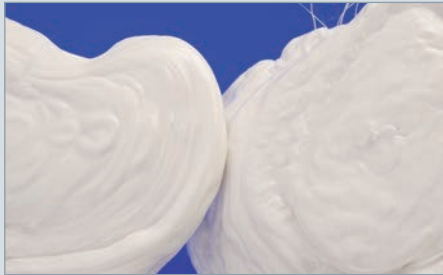
dry granules (moisture  
content of 0.01%)

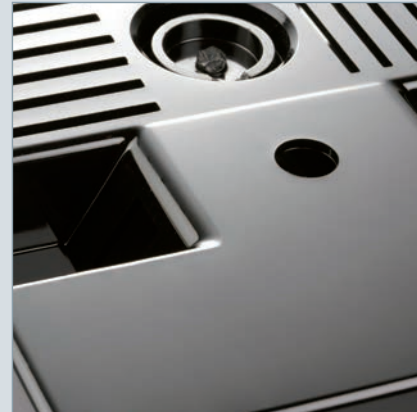
moist granules (mois-  
ture content of 0.12 %),  
melt cake with bubbles

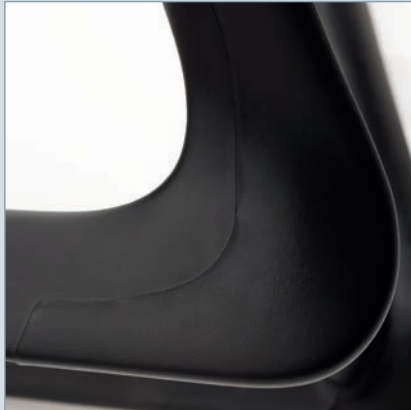
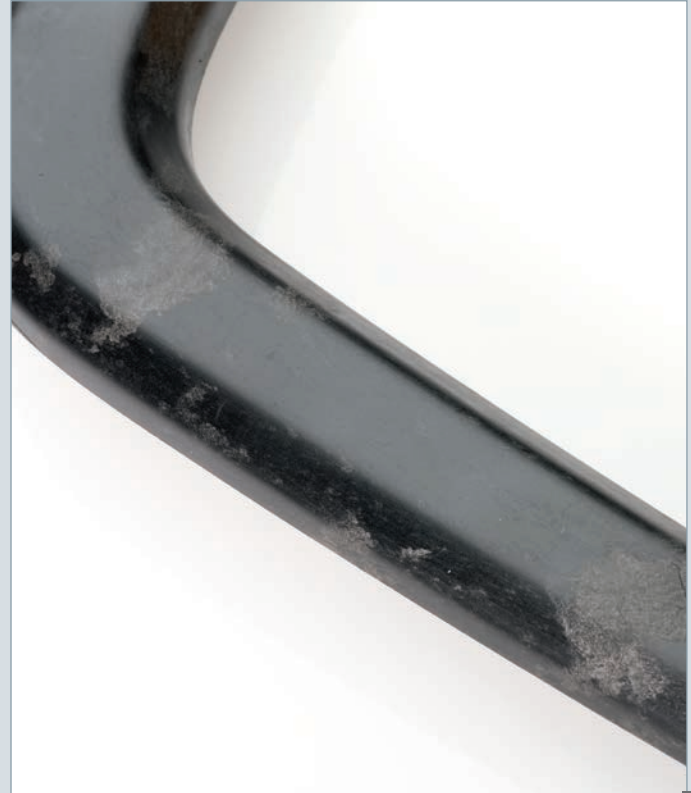
Glassfiber streaks caused by low mold temperature (glassfiber-reinforced  
Ultramid)

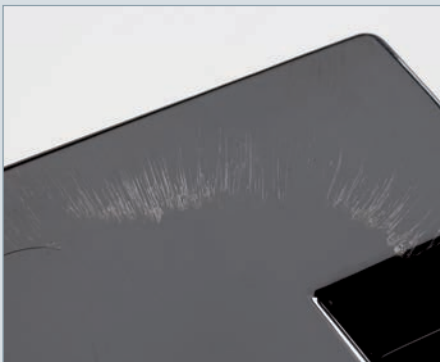
Burning streaks due to thermal degradation

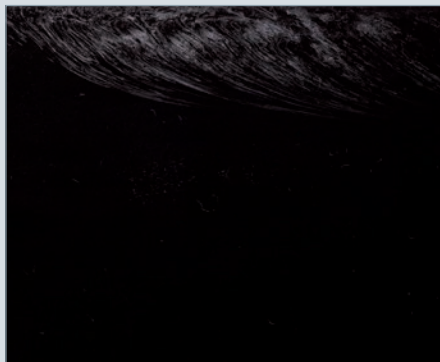
Burning streaks due to high shear in the gating system

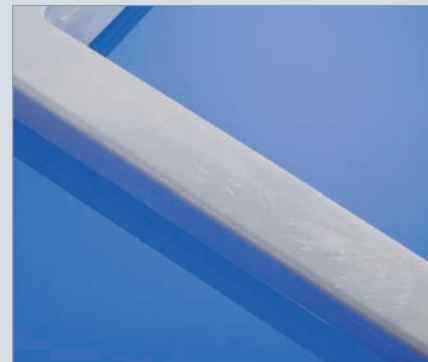
Streaks caused by thermal factors

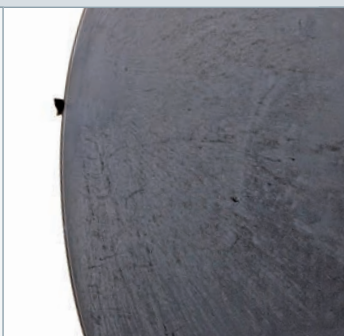
TM = 340 °C [644 °F]

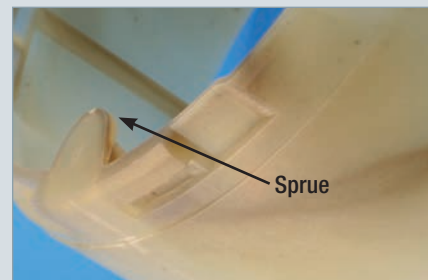
Burning streaks caused by excessively high shear in the gate (glassfiber-reinforced Ultrason®)

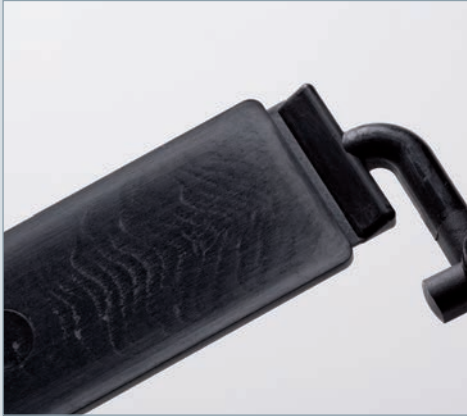
Tiger lines caused by a gate that is too small (glass-fiber-reinforced Ultramid®)

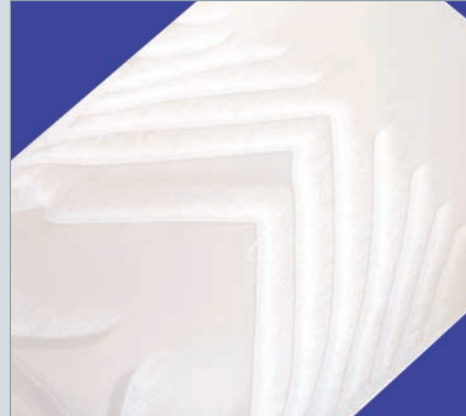
Tiger lines caused by unfavorable processing conditions (Ultraform®)

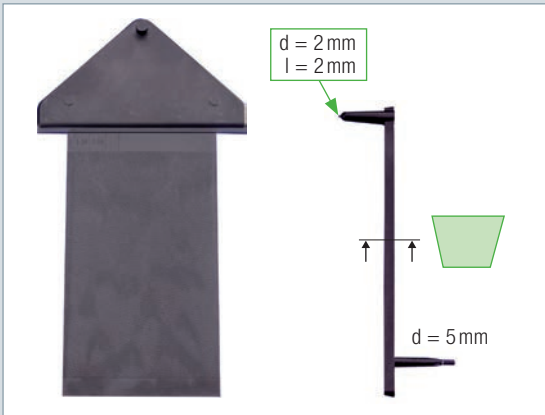
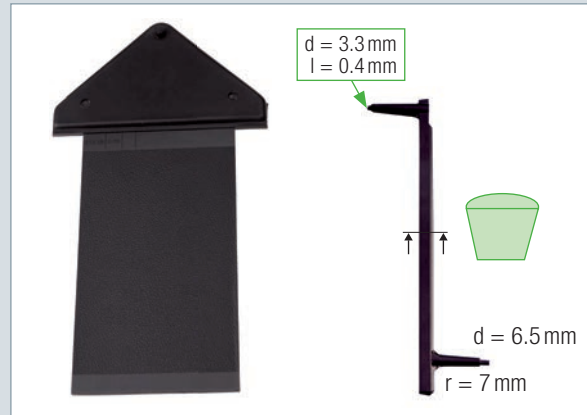
**Improved molded part surface due to an improved gating system with less pressure loss**

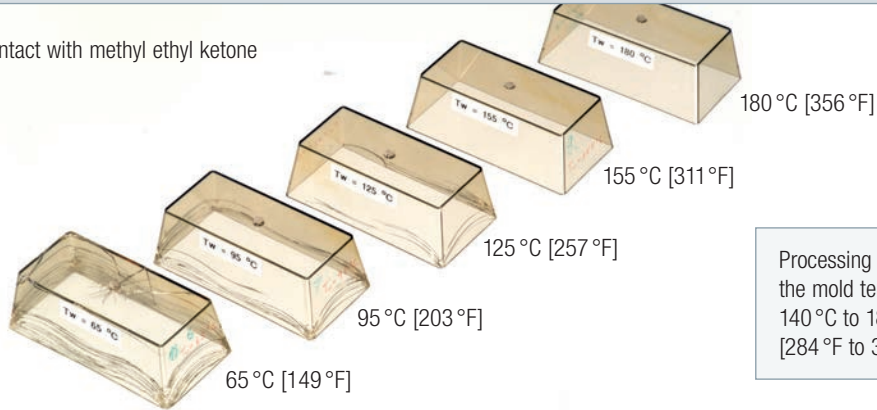
Processing window for  
the mold temperature:  
140 °C to 180 °C  
[284 °F to 356 °F]

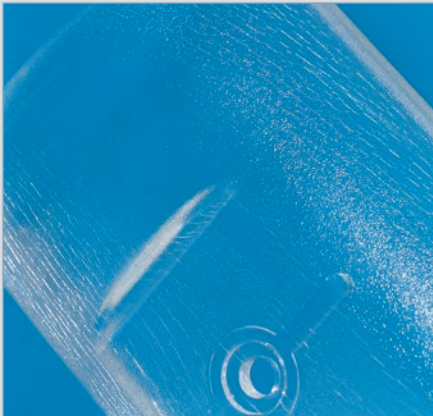
Stress cracks caused  
by overloading (hold-  
ing pressure too high)

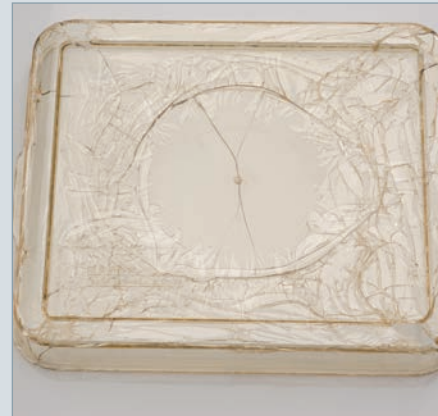
Stress cracks  
because of low  
mold temperature  
after media  
contact (Ultrason)

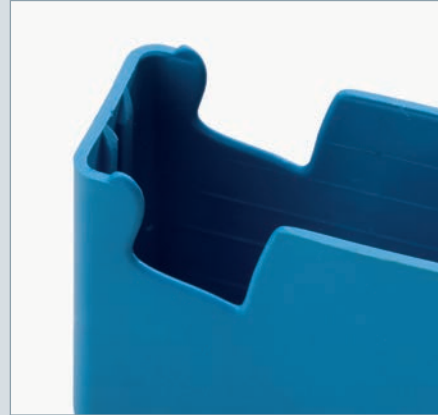
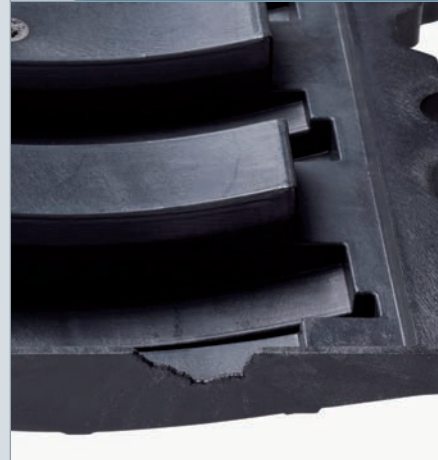
Incompletely filled  
molded parts

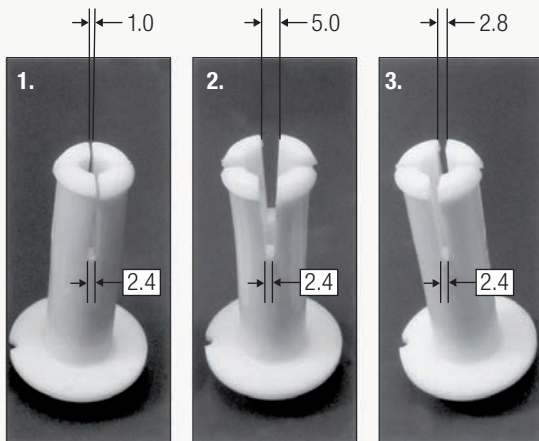
Holding mandrels made of Ultraform®

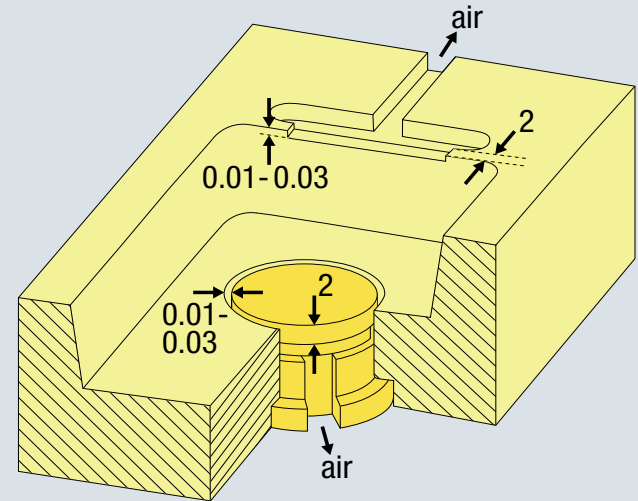
In the case of materials that flow easily select small venting slits of, for example, 0.01 mm to 0.02 mm, in order to avoid flash.
