Injection-Molding Problems in Engineering Thermoplastics

Causes and Solutions

BASF Plastics – key to your success

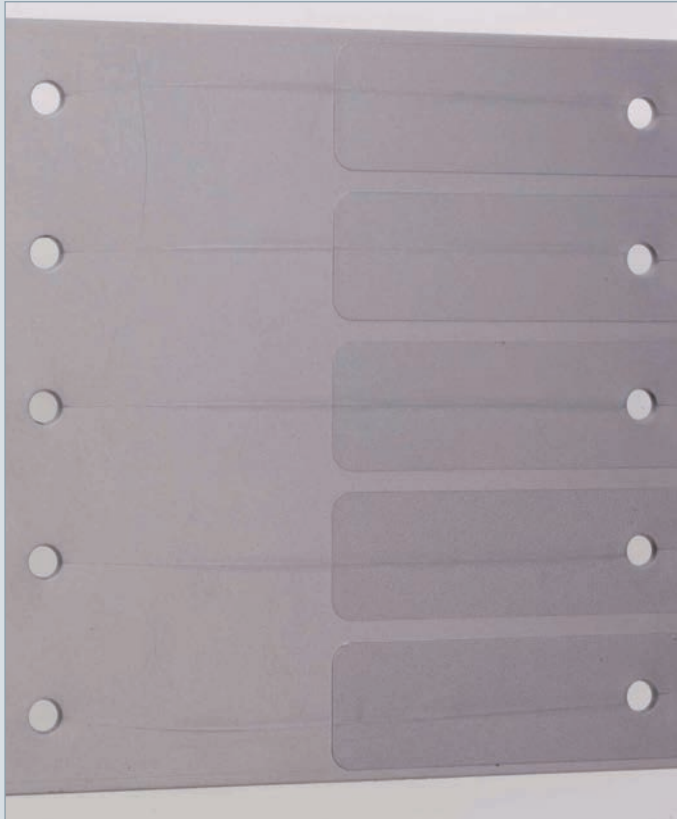
Weld lines after holes

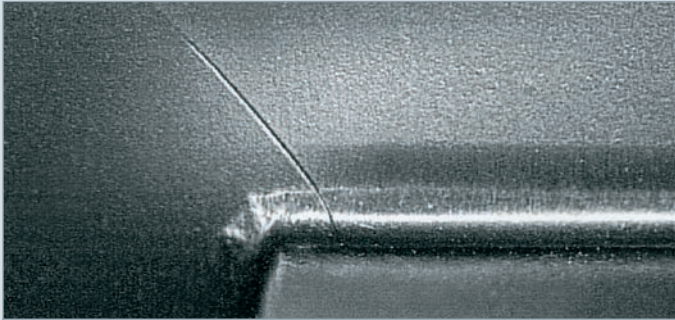
Vertical illumination, magnification 11:1

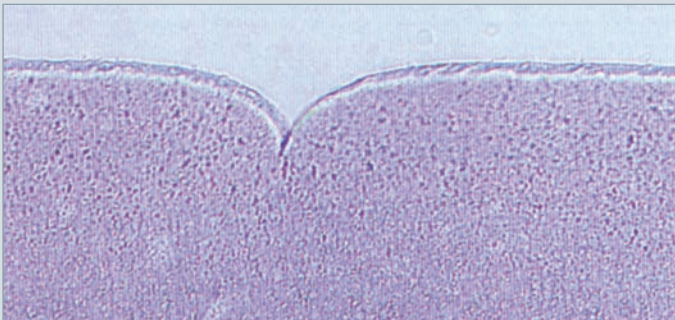
Transmitted light, polarized, magnification 560:1

Notches in a weld line

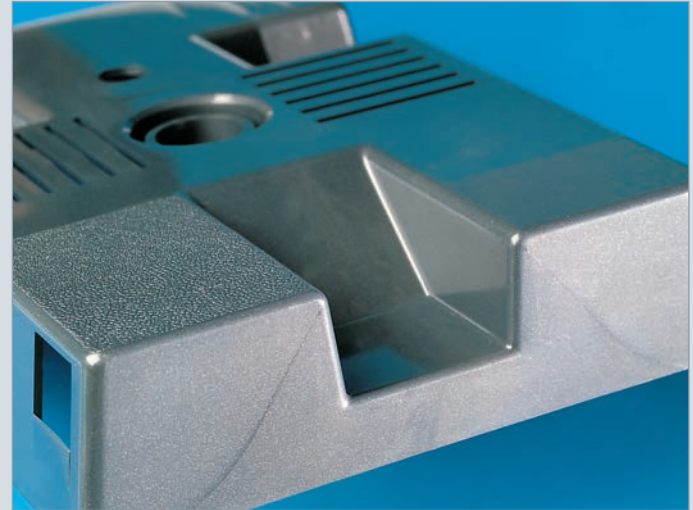
Weld line with metallic effect pigments

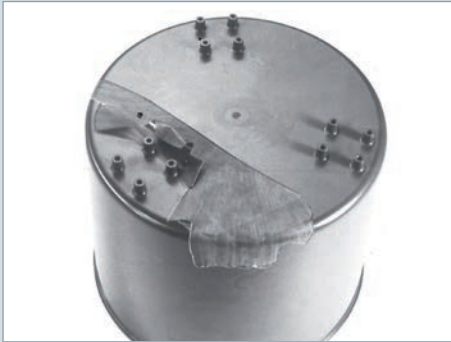
Delamination caused by an injection speed that is too high (mineral-filled Ultramid®)

Causes	Recommendations
<p>The layer formation is caused by excessive shear during the filling of the mold.</p>	<ul style="list-style-type: none"> • Increase the melt temperature. • Reduce the injection speed. • Reduce the pressure loss in the sprue and the runners by enlarging the cross section. • Change the gate type, for example, a film gate instead of a pin gate. • Increase the wall thickness of the molded part.
<p>The machine and possibly the hot runner are contaminated with foreign material.</p>	<ul style="list-style-type: none"> • Thoroughly clean the machine and the hot runner prior to processing.
<p>An incompatible masterbatch is used.</p>	<ul style="list-style-type: none"> • Check whether the masterbatch is appropriate for the plastic being used. If necessary, change to a masterbatch with a suitable carrier.
<p>Air becomes entrapped during the metering. Thin skins that can be pulled off are present on the surface of the molded part. This problem is encountered mainly with unreinforced, semi-crystalline thermoplastics.</p>	<ul style="list-style-type: none"> • Raise the back pressure while the material is being fed. • Check whether the maximum permissible metering stroke has been exceeded; if necessary, use a machine with a larger screw. • Use a screw with an optimized design, for example, a shallow-flighted three-zone screw.

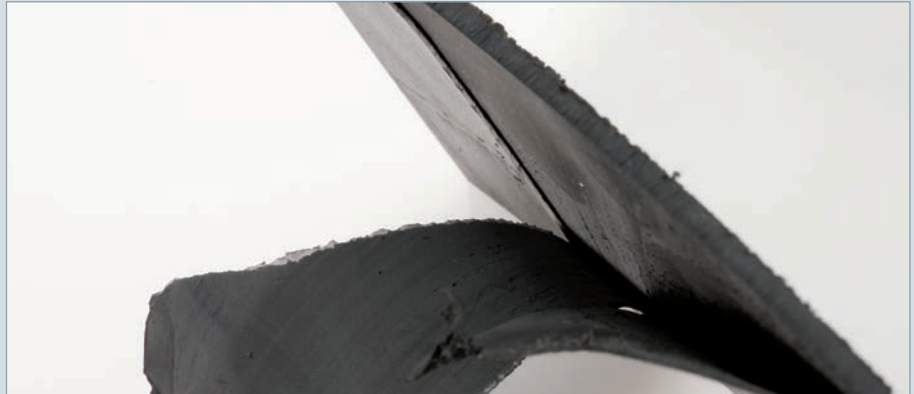
Delamination due to an injection speed that is too high (Ultramid T)

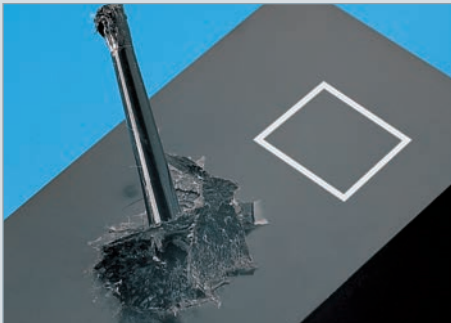
Delamination due to material contamination

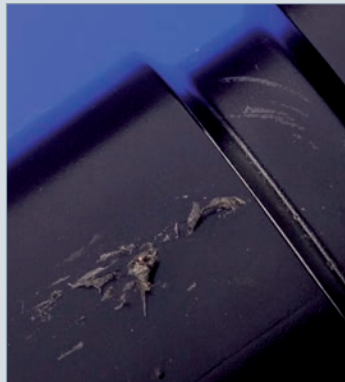
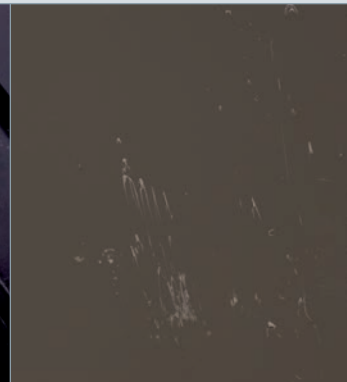
Delamination caused by entrapped air during metering (unreinforced Ultramid)

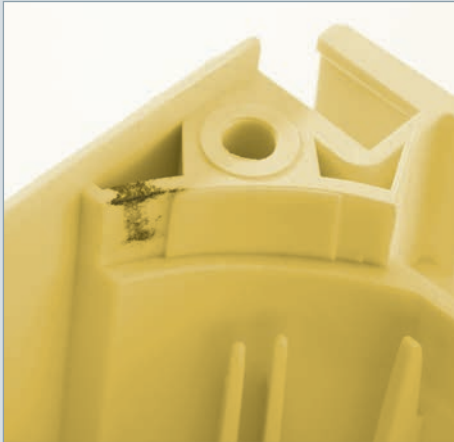
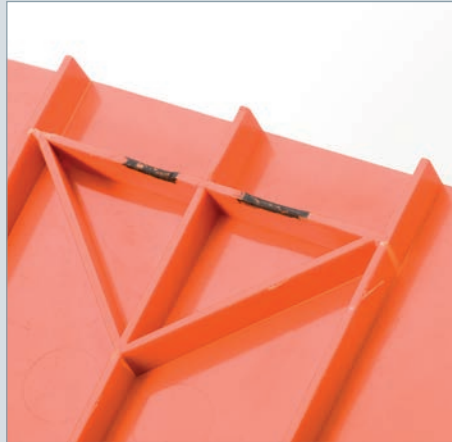
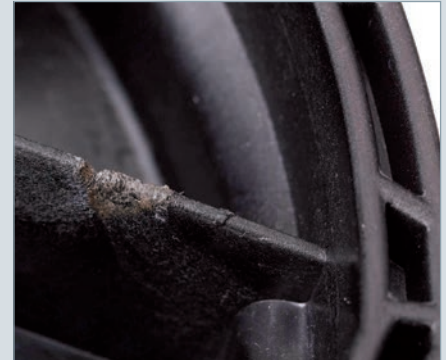
Diesel effect in a rib due to a lack of venting

Causes	Recommendations
The mold is filled at an injection speed that is too high.	<ul style="list-style-type: none">• Reduce the injection speed. It might already be sufficient to lower the speed only at the end of the filling phase (select a graduated injection profile).
The channels for venting the mold are contaminated or clogged by plate-out.	<ul style="list-style-type: none">• Clean the mold venting system and improve the vents.
The air cannot escape through the parting surface of the mold.	<ul style="list-style-type: none">• If the burning occurs close to the parting surface, reduce the clamping force of the machine.
The mold is insufficiently vented.	<ul style="list-style-type: none">• Check the venting channels in terms of their position and effectiveness. If applicable, provide additional venting channels in the parting surfaces and/or install core pins in the mold at the places where melt flows meet.

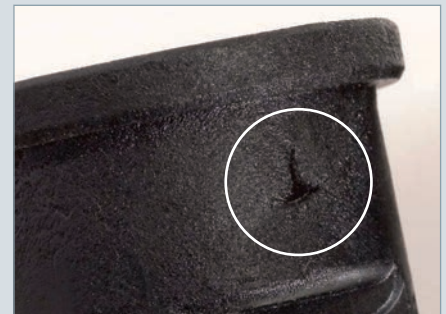
The flow pattern shows the weld lines of several melt flows.

Several melt flows meet.	<ul style="list-style-type: none">• Analyze the filling situation. Adjust the flow pattern by optimizing the gate position or by providing flow promoters in such a way that the air can escape through the parting surfaces of the mold.

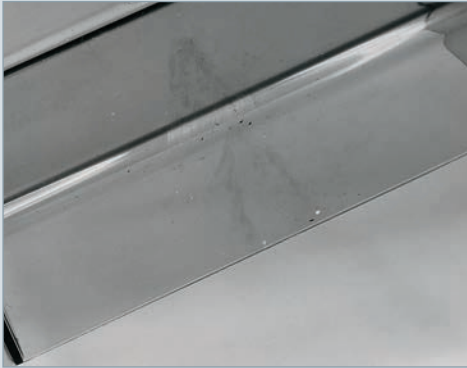
Black specks

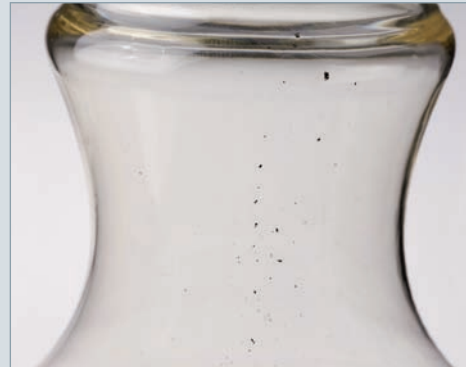
Impurities in a bottle due to dead spots in the plasticizing unit

Causes	Recommendations
The material is contaminated with foreign matter.	<ul style="list-style-type: none"> • Reduce the time during which the granules are exposed to the open. • Check the condition of the material conveying system for possible leakages, dirt deposits or wear and tear. • Thoroughly clean the material conveying system, the dryer and the machine prior to any material change.
The temperature of the melt is too high.	<ul style="list-style-type: none"> • Check the melt temperature and, if necessary, lower the temperature of the barrel and of the hot runner. • Reduce the screw speed and the back pressure.
The material degrades in so-called dead spots in the plasticizing unit and/or in the hot runner.	<ul style="list-style-type: none"> • Check the design of the plasticizing unit (non-return valve, machine head, machine nozzle) and of the hot runner system and eliminate all dead spots.

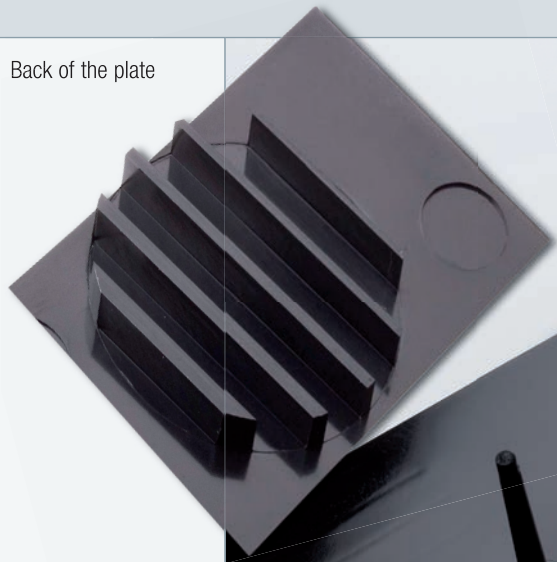
Sink marks caused by ribs (glassfiber-reinforced Ultramid®)

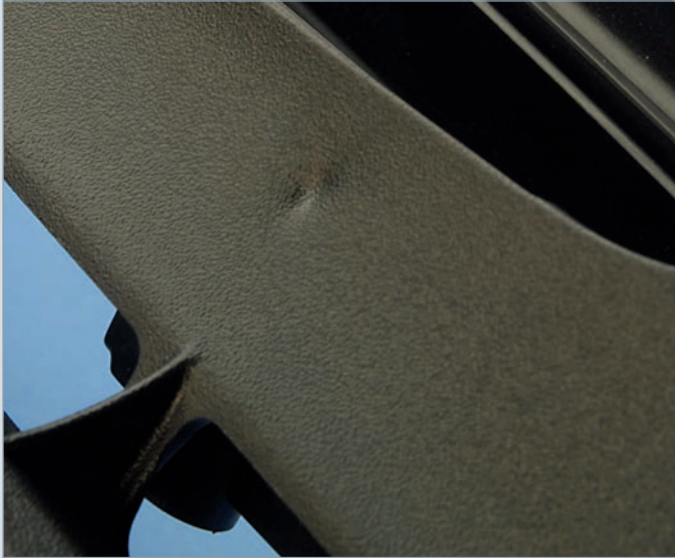
Sink mark in a section with an increase of wall thickness: the design of the screw-in mandrel is not appropriate for processing this plastic

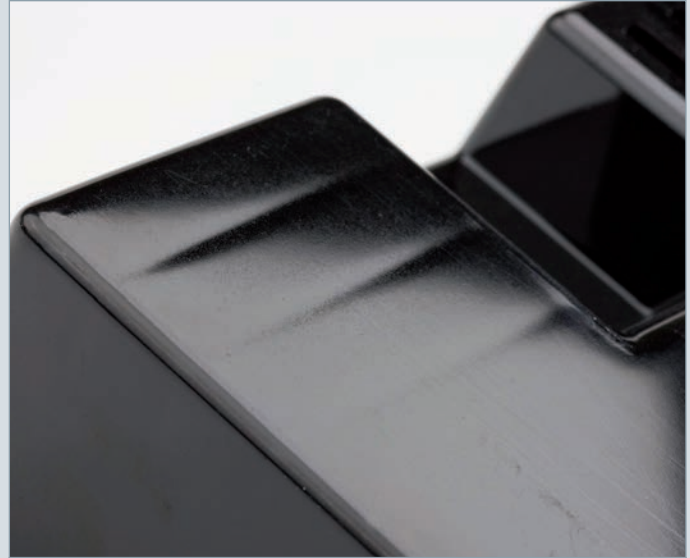
Sink marks caused by ribs

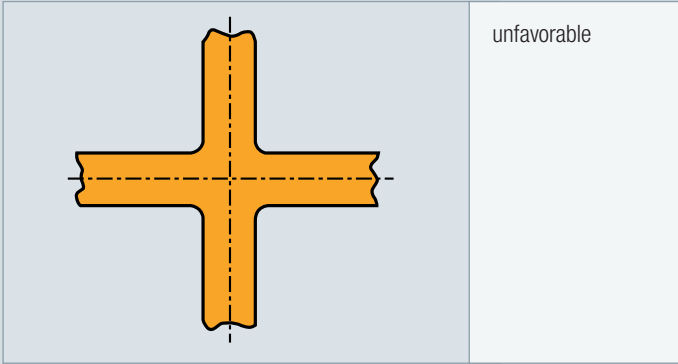
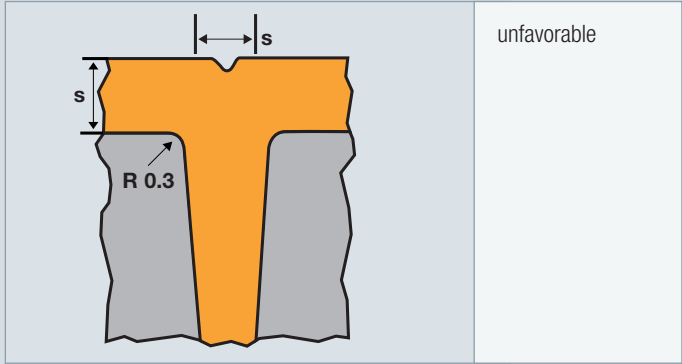
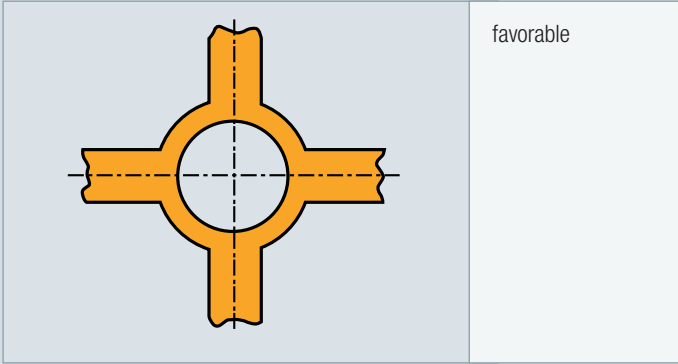
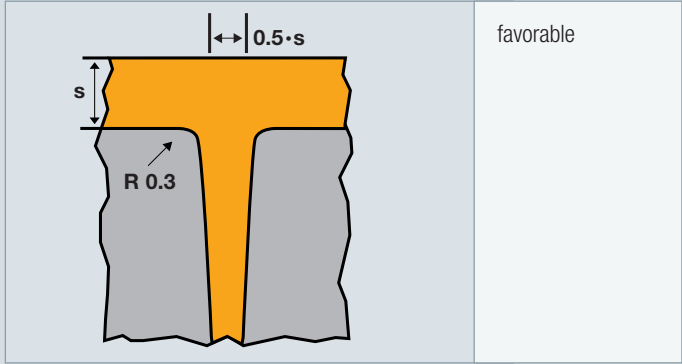
Avoiding sink marks (voids) by designing the rib connection so as to be appropriate for processing this plastic

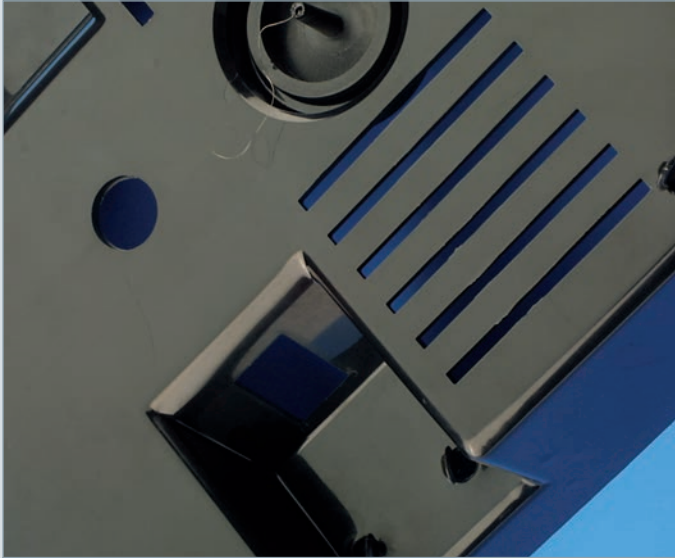
The ejectors puncture the molded part because the cooling time is too short.

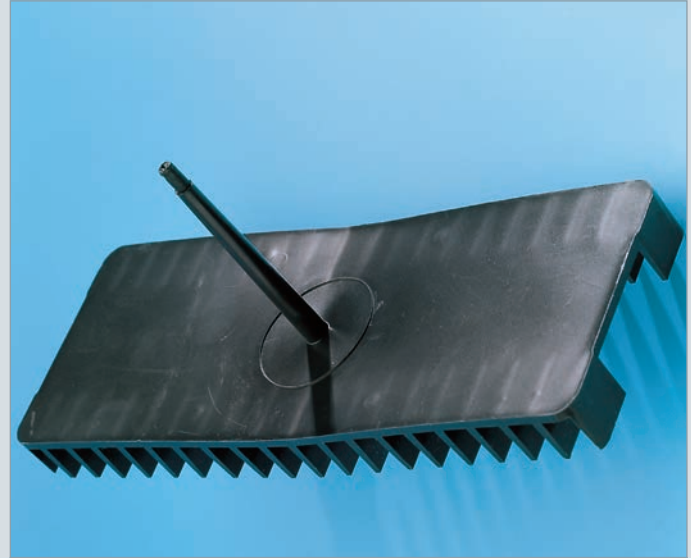
Mold-removal problems caused by overpacking (holding pressure is too high)

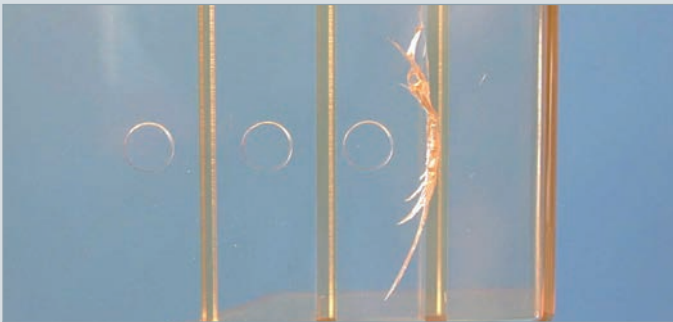
Rib without draft, asymmetrical arrangement of the ejectors

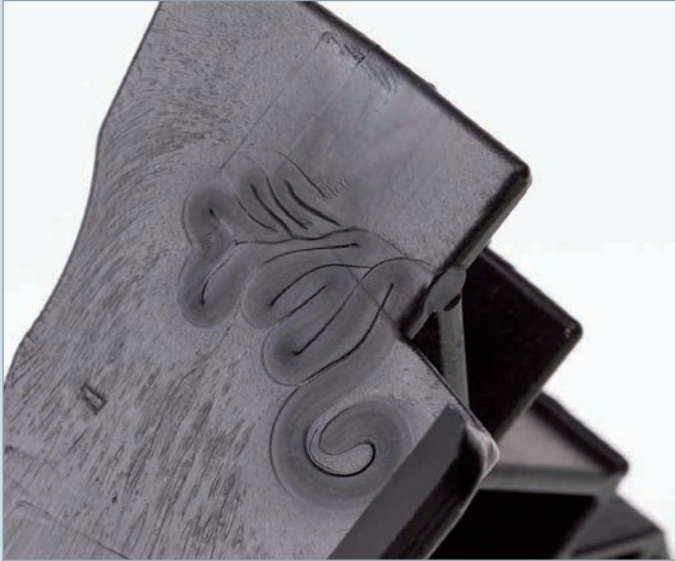
Jetting due to the unfavorable position of the gate

Causes	Recommendations
The position selected for the gate is incorrect. The gate design is not suitable.	<ul style="list-style-type: none">• Change the gate position in such a way that the emerging polymer melt strikes an obstacle immediately beyond the gate.• Enlarge the cross section of the gate.• Round off the transition area between the gate and the molded part.
Unfavorable process conditions during the filling procedure.	<ul style="list-style-type: none">• Reduce the injection speed.• Increase the melt temperature.
The design of the molded part is not appropriate for processing this plastic (for example, sudden changes in the wall thickness along the flow path).	<ul style="list-style-type: none">• Change the design of the molding so as to prevent sudden changes in the wall thickness.

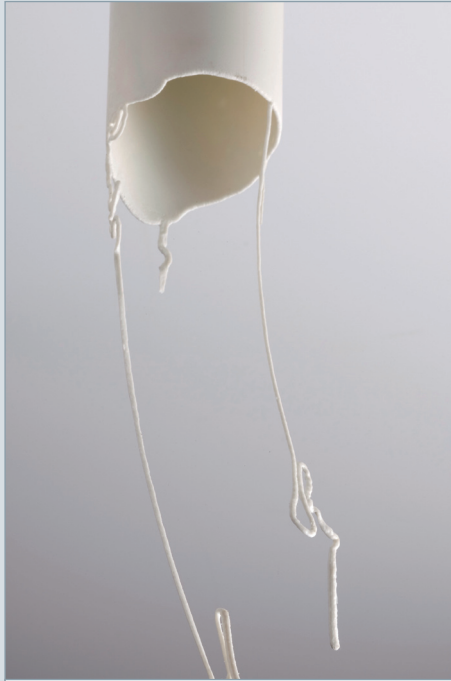
Jetting on a sleeve caused by three-fold gating through a pin gate

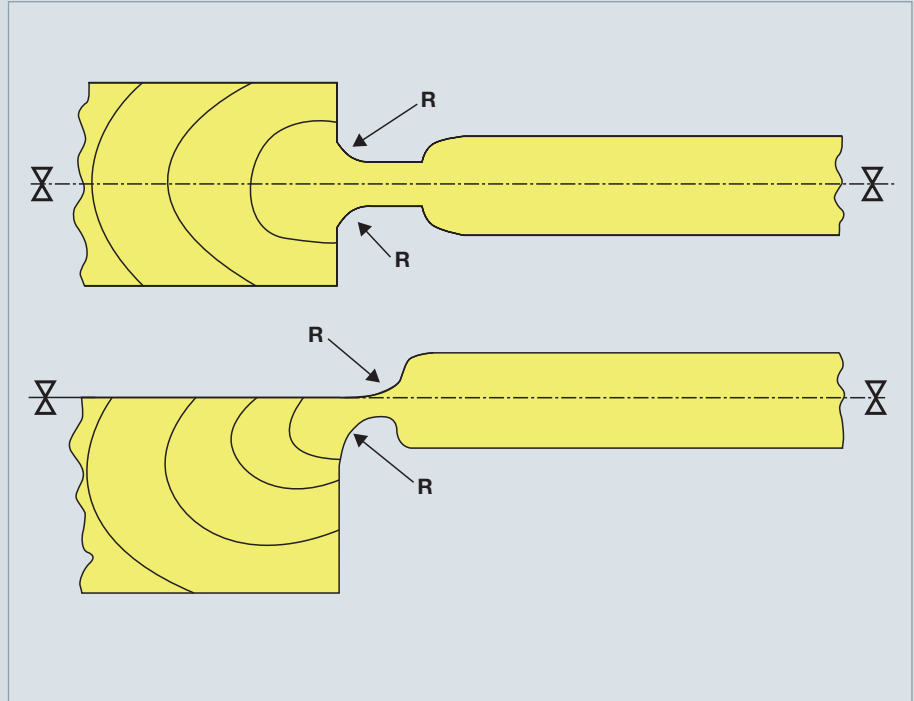
Ensure proper radii in the transition area from the gate to the molded part

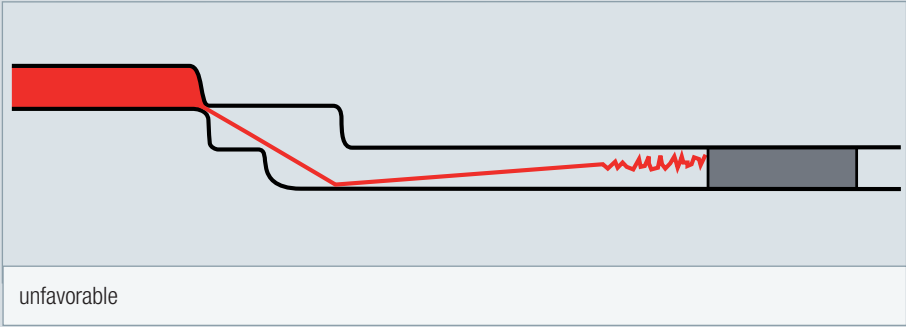
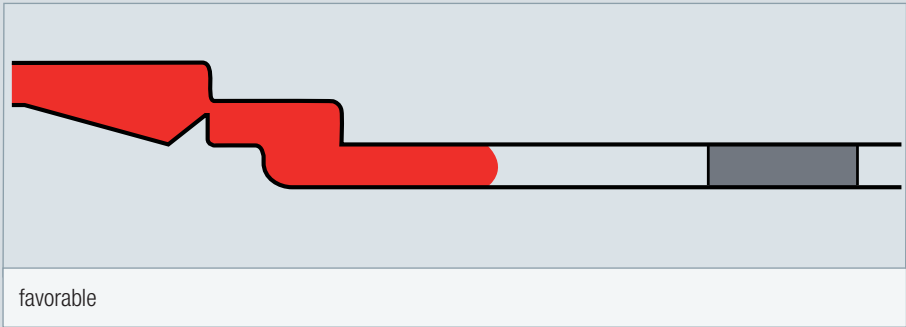
Gate design

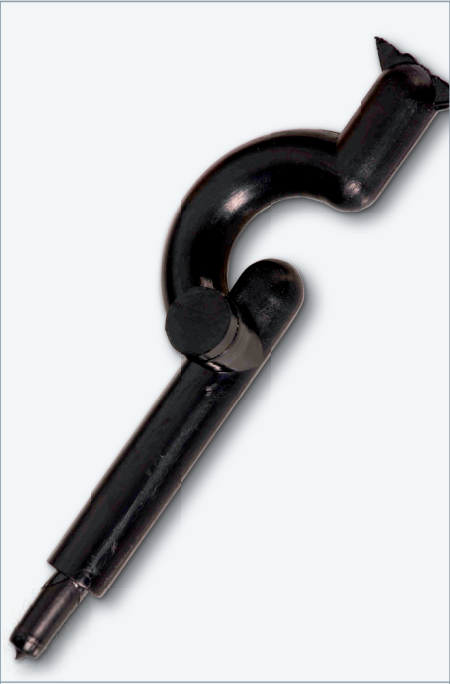
Melt deflection in order to prevent jetting (injection via the parting surface)

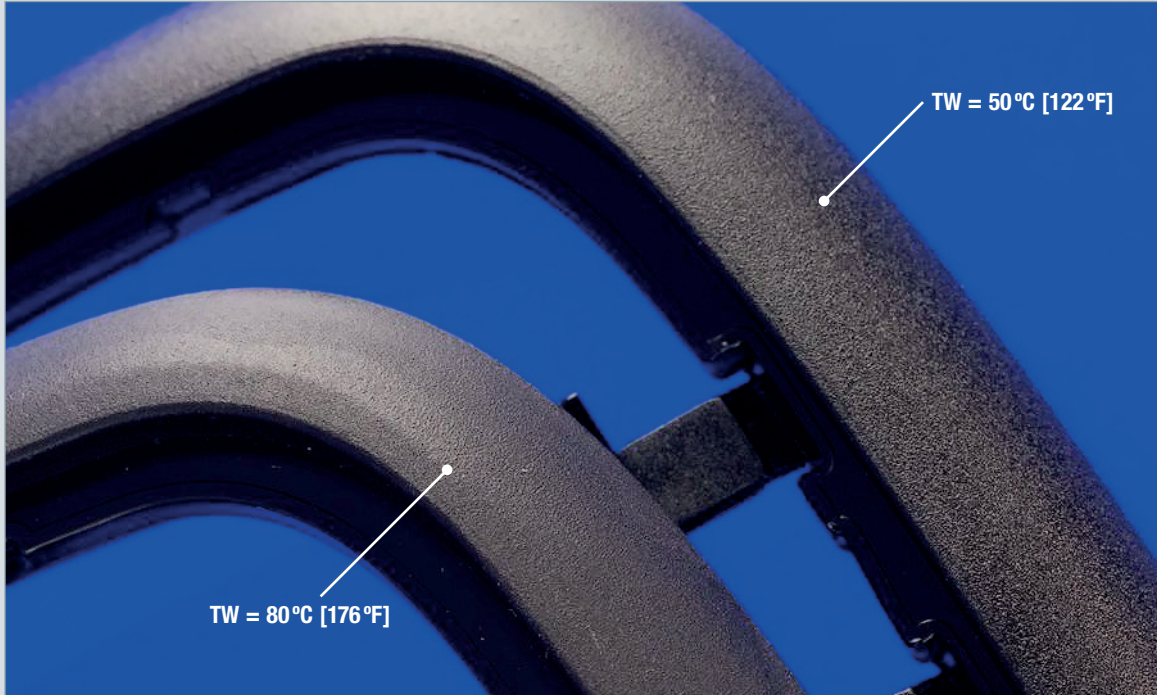
Influence of the mold temperature (TW) on the gloss (glassfiber-reinforced Ultramid®)

Causes	Recommendations
Sudden changes in the wall thickness caused by ribs or by mounting bosses. These sink marks lead to differences in the gloss.	<ul style="list-style-type: none"> • Prevent material accumulations and sudden changes in the wall thickness; as much as possible, gate the molded part in the area where the wall is the thickest.
Differences in the gloss are visible in the area of weld lines, for example, due to a changed orientation of the melt and to changed flow conditions.	<ul style="list-style-type: none"> • Check whether, by modifying the gate position or by using flow promoters or flow retarders, the position of the weld lines can be changed to places where they do not interfere; a filling simulation is helpful in such a case.
The temperature of the mold wall, the temperature of the melt and the injection speed as well as the change-over to holding pressure have not been well-chosen.	<ul style="list-style-type: none"> • Increase the mold temperature. • Increase the melt temperature. • Optimize the injection speed. • Optimize the switch-over point in such a way that, shortly before the volumetric mold filling level has been reached (filling level of approximately 98%), a change is made to holding pressure.

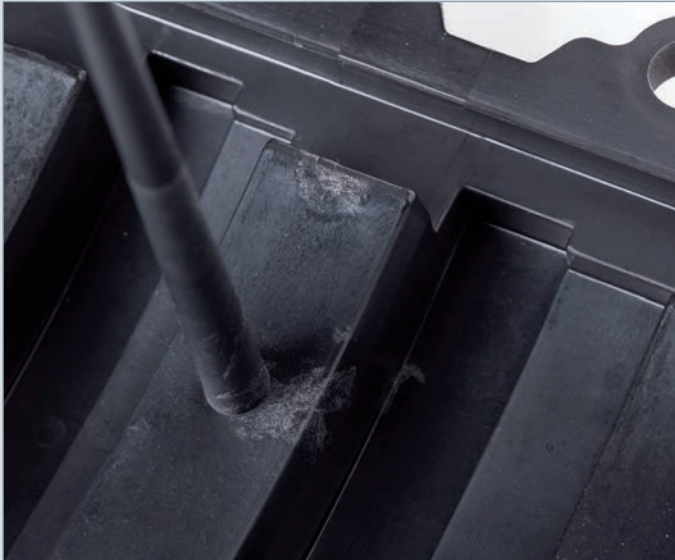
Cold slug from the bore of a machine nozzle that has cooled and broken off (glassfiber-reinforced Ultradur®)

Causes	Recommendations
The temperature of the machine nozzle is too low.	<ul style="list-style-type: none"> • Increase the nozzle temperature.
The machine nozzle is unheated or the output of the band heaters is too low.	<ul style="list-style-type: none"> • Heat the machine nozzle with additional heater bands. • Raise the output of the band heaters or install several heater bands on the machine nozzle.
The material drips out of the machine nozzle or out of the hot runner, cools off and is injected into the cavity at the time of the next shot.	<ul style="list-style-type: none"> • After plasticizing decompress the melt by retracting the screw a few millimeters. • Reduce the back pressure. • Lower the temperature of the machine nozzle. • Use a needle shut-off mechanism for the machine nozzle or for the hot runner nozzle. • Incorporate a cold slug area (catcher) within the sprue/runner.
The bore of the machine nozzle does not have any draft.	<ul style="list-style-type: none"> • Modify the bore of the machine nozzle with a reverse draft.

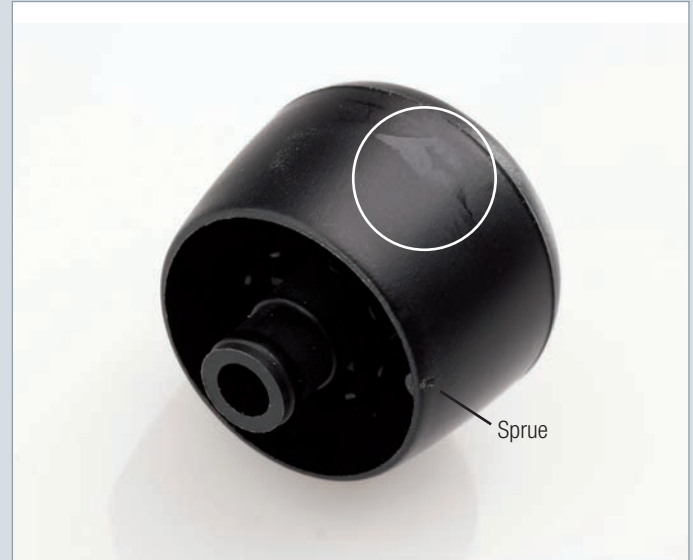
Cold slug in a molded part made of glassfiber-reinforced Ultramid®

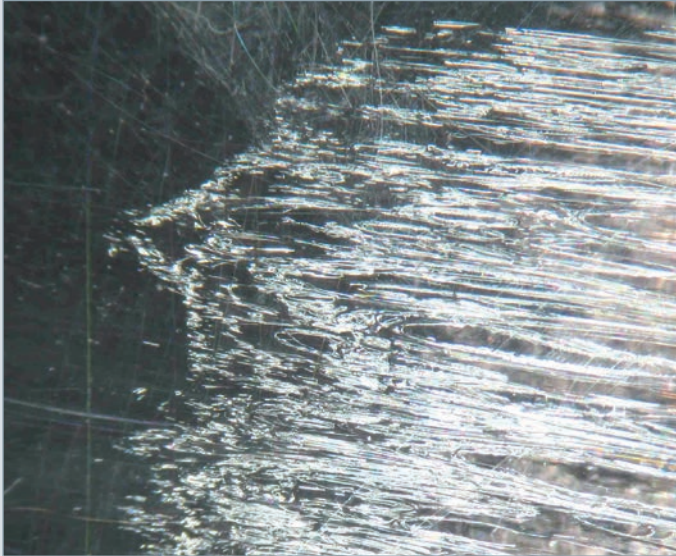
Streaks in Ultrason® caused by cold slug

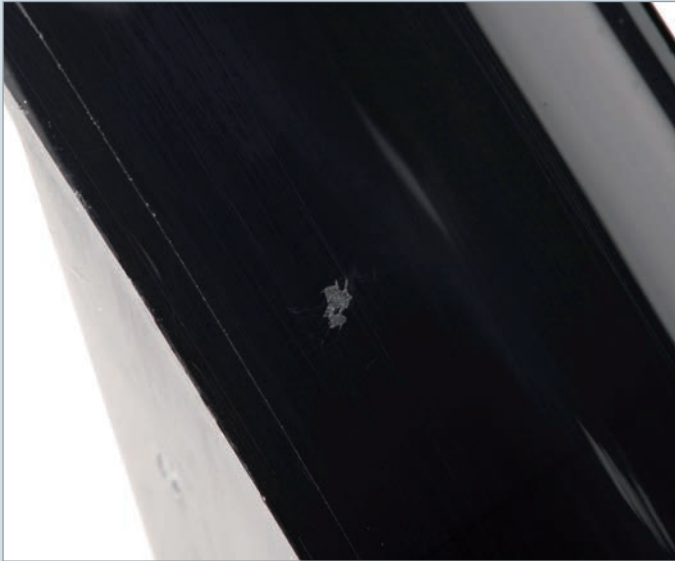
Surface blemish caused by a gate that has broken off (unreinforced Ultradur)

The tip of the tunnel gate breaks off when the part is removed from the mold and ends up in the cavity at the time of the next shot.	<ul style="list-style-type: none"> • Modify the angle of the gate in a way that is appropriate for the material. • Do not use a tunnel gate for brittle plastics.

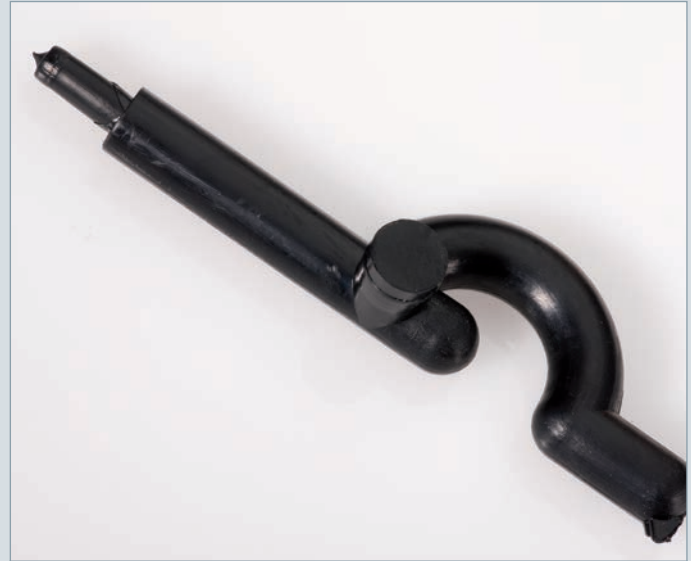
Cold slug catcher in a gate with a deflection in order to prevent jetting (injection through the parting surface)

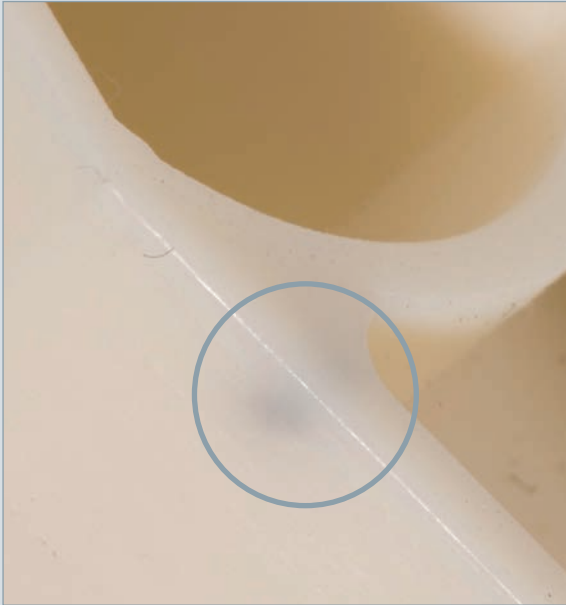
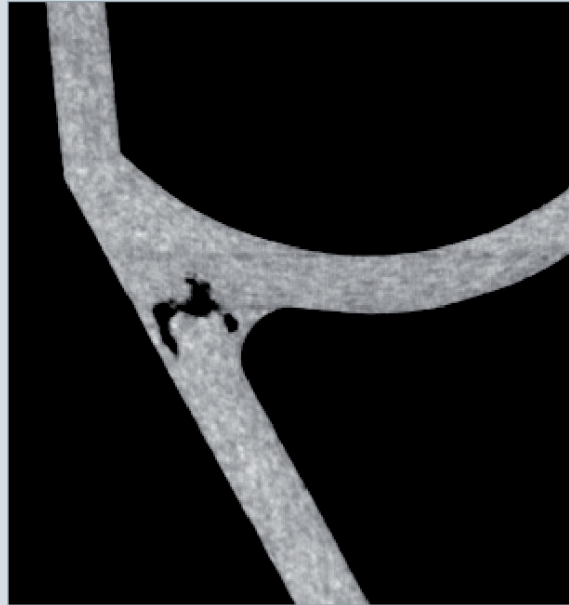
Image of a section of a molded part, taken by 3D computer tomography

Air entrapment in a housing made of glassfiber-reinforced Ultradur®

Causes	Recommendations
During the mold filling, air is entrapped due to the molded part design and gating.	<ul style="list-style-type: none">• Change the filling pattern by adding flow promoters and/or flow retarders.• Change the position of the gates. (In both cases it is recommended that the filling pattern be optimized by means of a moldflow study.)
After the plasticizing, air present in front of the screw or in the hot runner is entrapped in the melt because the screw decompression is too intense or too fast.	<ul style="list-style-type: none">• Shorten the path of the screw decompression.• Decompress at a reduced screw retraction speed.
During the plasticizing of the material, air is entrapped via the screw because of processing conditions or because a screw that is not appropriate for the material is being used.	<ul style="list-style-type: none">• Increase the back pressure when the material is being metered in.• Lower the temperature in the feed zone.• Check whether the maximum permissible metering stroke has been exceeded; if necessary, use a machine with a larger screw diameter.• Use a screw with an optimized design, for example, a shallow-flighted three-zone screw or a screw with a shorter feed zone.

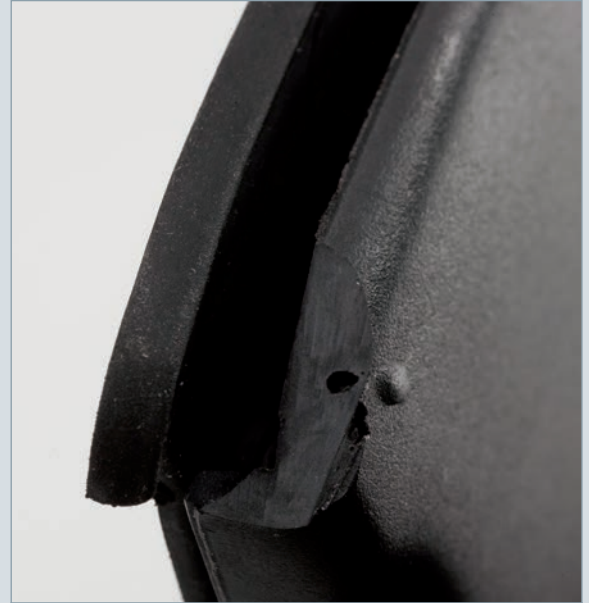
Air entrapment caused by an unfavorable molded part design

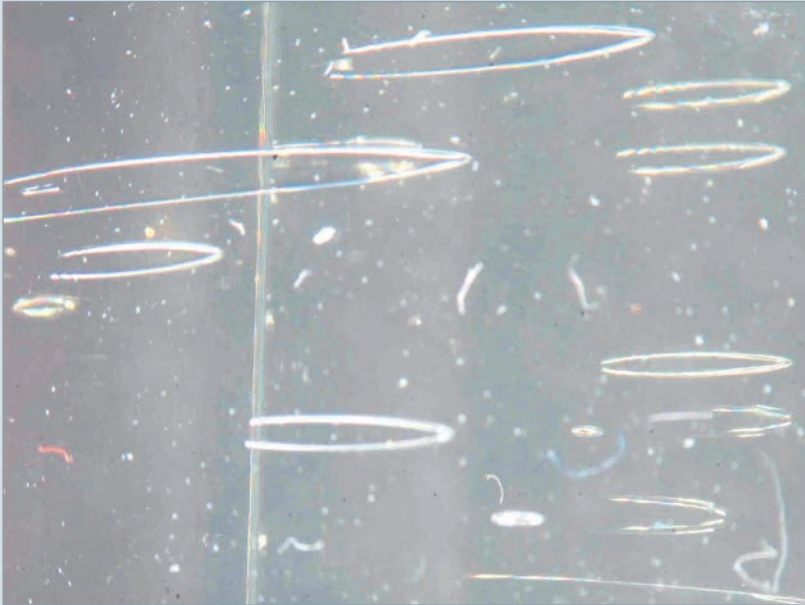
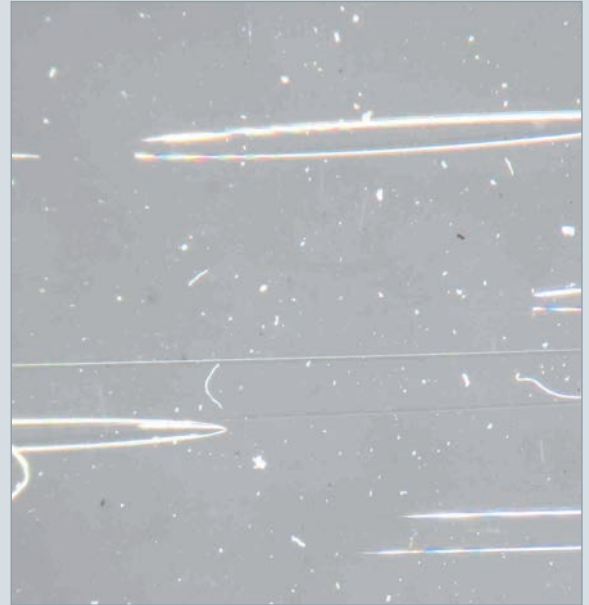
Streaks caused by entrapped air (Ultrason®)

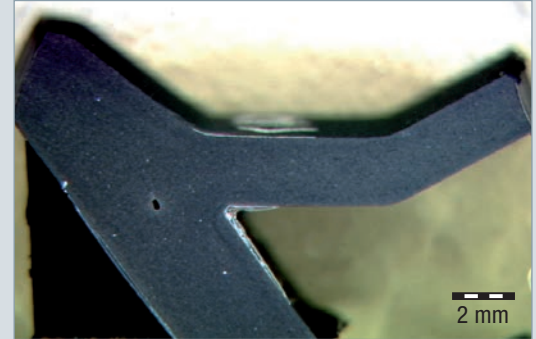
Voids in molded parts made of glassfiber-reinforced Ultramid®

Images taken by 3D computer tomography

Hollow spaces in the form of microcells or bubbles are formed inside the plastic molded part during or after the cooling phase. In contrast to gas bubbles, voids always occur in the molten center of the plastic (normally the middle of the wall) and in areas with thick sections. Drilling into the part while holding it under water shows whether water is penetrating (voids) or not (gas bubbles). As is the case with sink marks, voids are also formed in areas of high volume shrinkage due to inadequate packing of the material. Voids are formed instead of sink marks whenever the edge layers have solidified to such an extent that they no longer yield to the contraction forces when the material cools off.

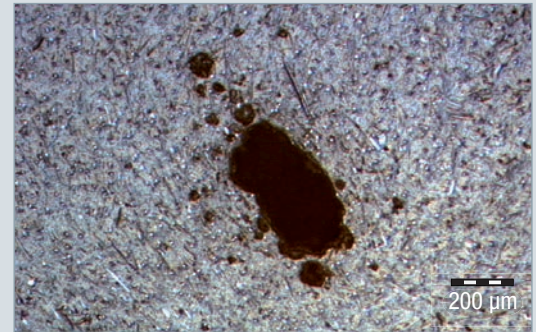
Detail from image above, polished section, optical light microscopic image with vertical illumination

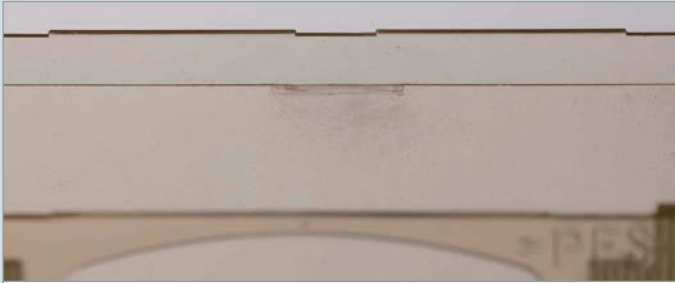
Dull spots in the area of a film gate

Halo-like dull spots are often formed in the area of gates; sometimes they also occur behind cross section transitions. The causes for this are the high shear stresses at these places as well as the diminished adhesion of the plastic to the wall due to the cross section transitions.

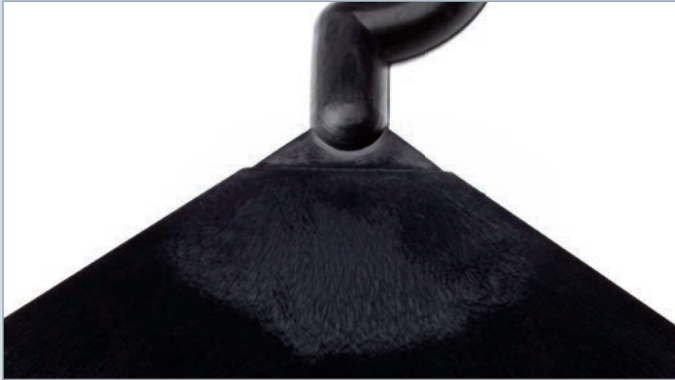
Dull spots caused by a cross section transition

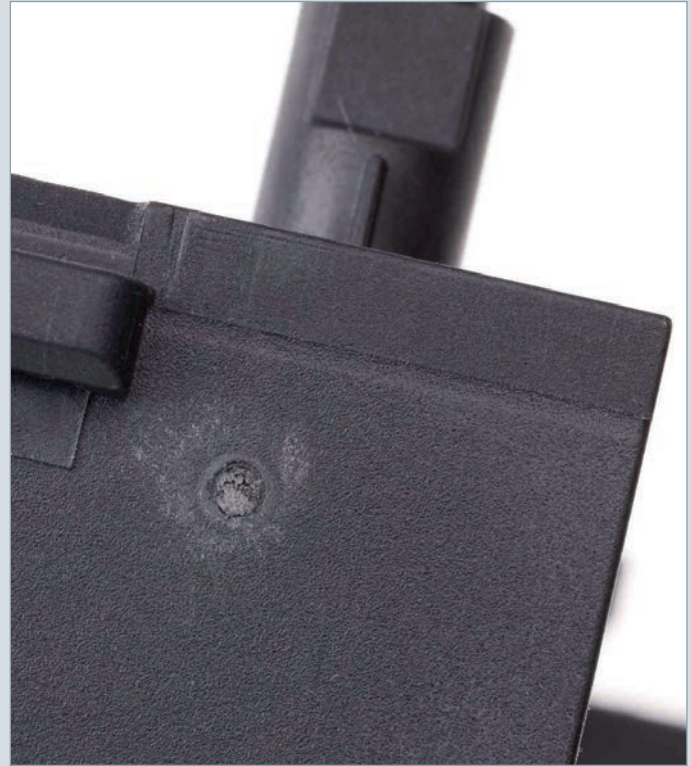
Dull spots in the area of the gate caused by high shear

Causes	Recommendations
The selected injection speed is too high.	<ul style="list-style-type: none">• Optimize the injection speed, set a graduated profile (slow – fast).
The gate is not optimally configured.	<ul style="list-style-type: none">• Optimize the gate. To the extent possible, the gate should be designed so as to be rounded, having an adequate cross section.
The temperature selected for the melt is too low.	<ul style="list-style-type: none">• Increase the melt temperature.
There is an abrupt cross section transition.	<ul style="list-style-type: none">• Optimize the design of the molded part; ensure a gradual cross section transition.
The molded part is gated at an unsuitable place.	<ul style="list-style-type: none">• Move the feed point to a less critical area or gate the molded part via a separate runner located outside the visible area.

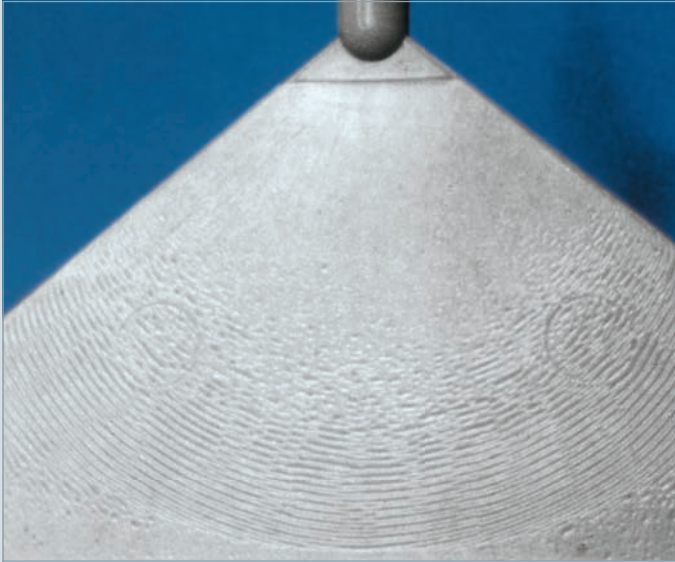
Record grooves effect because the melt temperature and the injection speed are too low

Causes	Recommendations
The selected mold temperature, melt temperature and injection speed are too low.	<ul style="list-style-type: none">• Increase the temperature of the mold surface.• Select a higher injection speed.• Increase the melt temperature.
The design of the molded part is not appropriate for processing this plastic (for instance, thicker walls at the end of the flow path or a sudden change in the wall thickness).	<ul style="list-style-type: none">• Optimize the geometry of the molded part and avoid sudden changes in the wall thickness.
A large pressure loss has occurred in the gating system.	<ul style="list-style-type: none">• Increase the gate diameters.

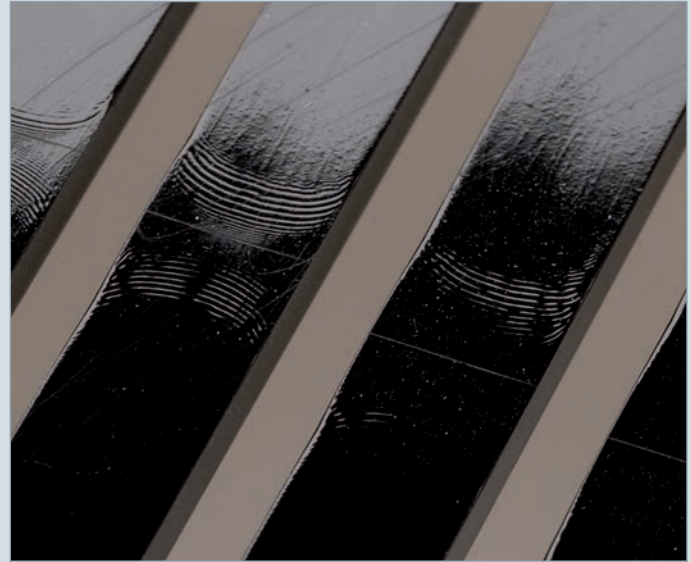
Record grooves effect at the end of the flow path because the melt viscosity is too high

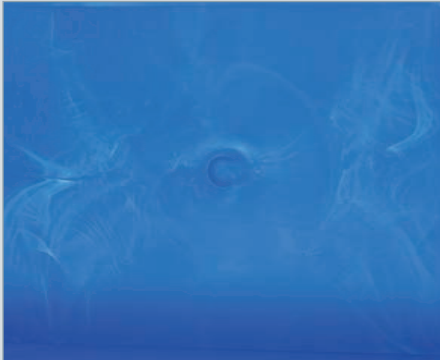
Colored streaks caused by the use of an unsuitable masterbatch

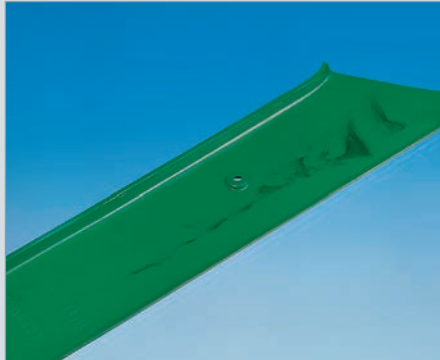
Colored streaks due to impurities in the hot runner

Foreign material accumulates in dead spots in the plasticizing unit and/or in the hot runner.

- Thoroughly clean the plasticizing unit and the hot runner.

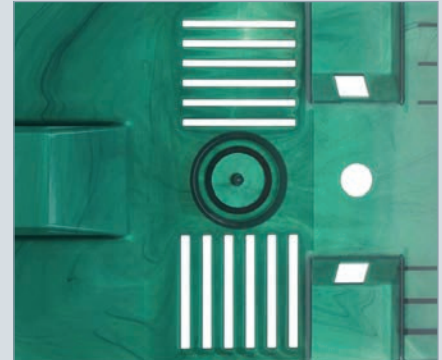
Colored streaks caused by the use of a screw with an unsuitable geometry

The selected plasticizing unit is unsuitable for self-coloring due to inadequate dispersing action.

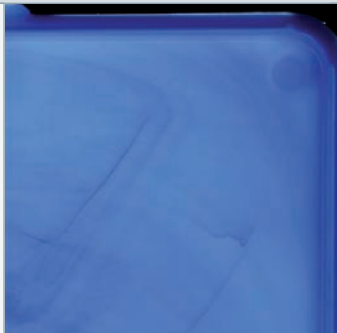
Avoidance of colored streaks by using mixing sections

Ultraform® N2320 003
+ 0.5 % batch blue

Non-return valve

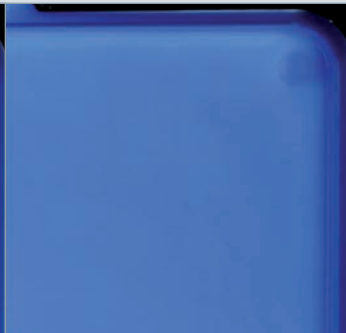
BASF mixing ring

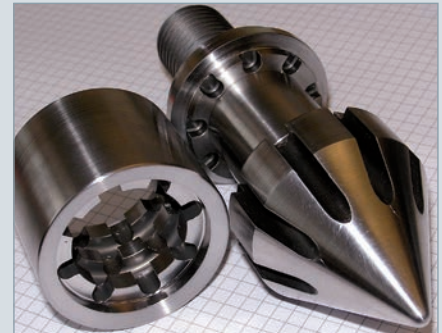
BASF mixing ring

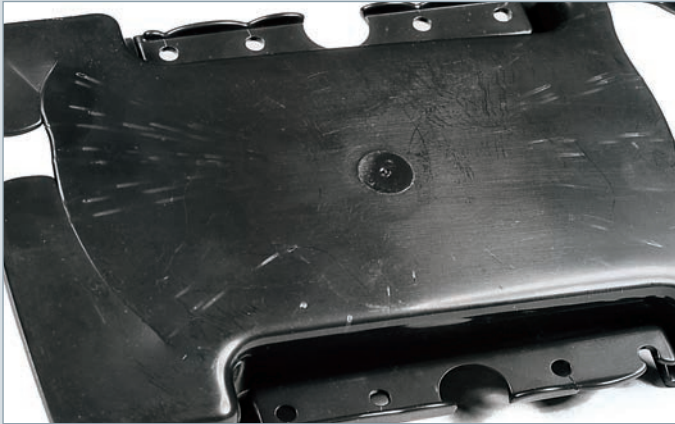
**Moisture streaks
in Ultrason®**

The material has too much residual moisture. When it is melted, steam vapor bubbles are formed that burst while the mold is being filled and come to lie on the surface of the molded part.

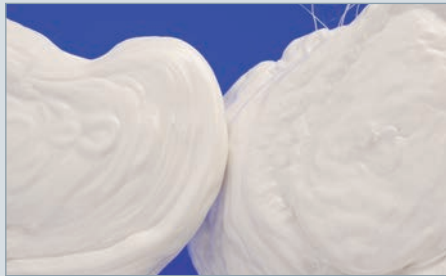
**Processing of
moist Ultradur®
(purged melt
cake)**

dry granules (moisture content of 0.01%) moist granules (moisture content of 0.12%), melt cake with bubbles

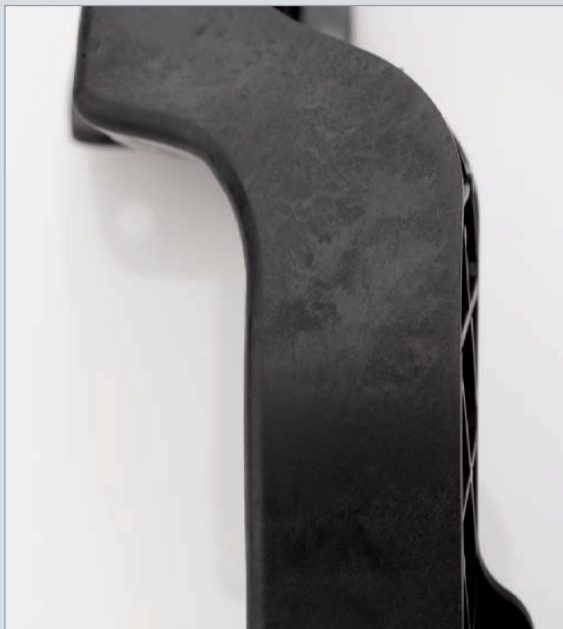
Glassfiber streaks influenced by the product

glassfiber-reinforced PA

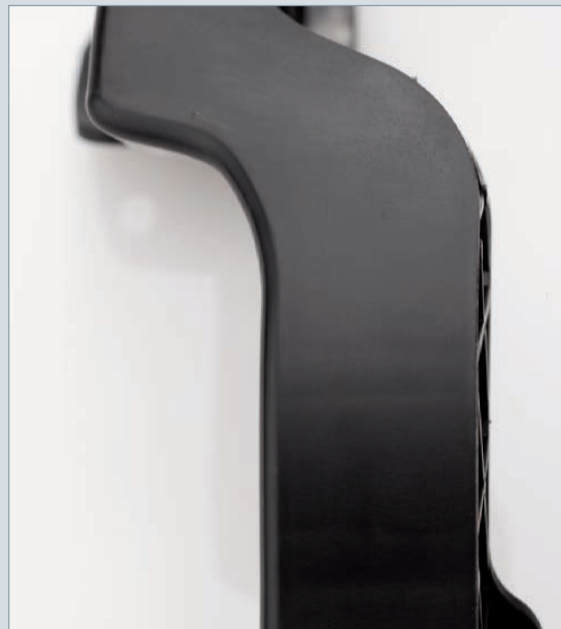
glassfiber-reinforced Ultramid® High Speed

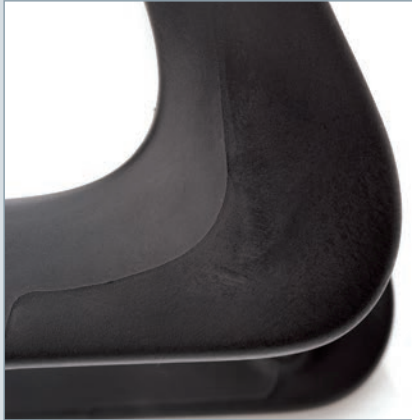
glassfiber-reinforced
PA

glassfiber-reinforced
Ultramid Surface
Improved (SI)

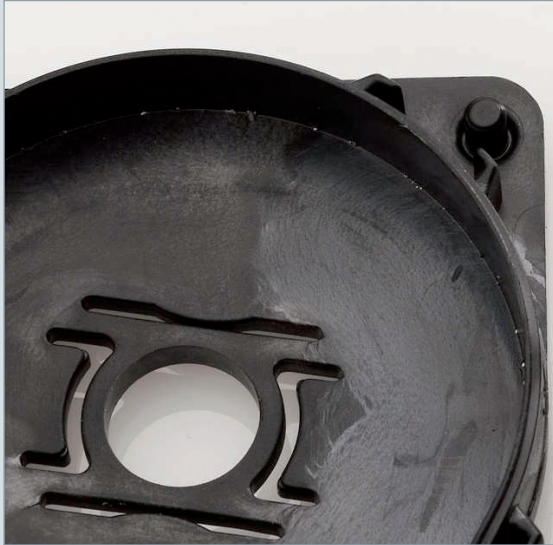
Streaks in a molded part made of mineral-filled Ultramid – optimization of the processing conditions

TM = melt temperature
v = injection speed

TM = 260 °C [500 °F], v = low

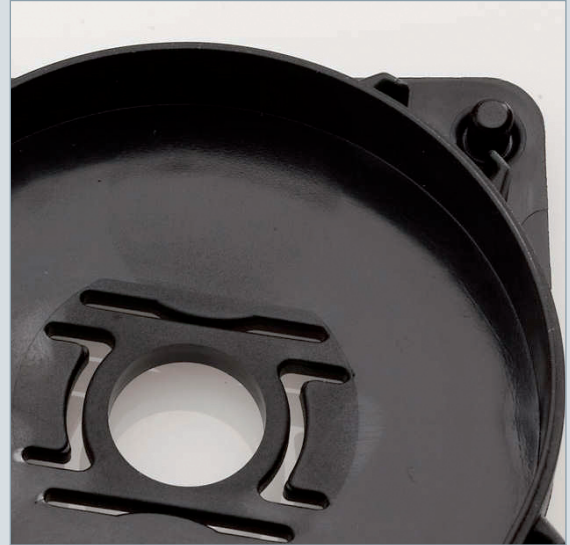
TM = 280 °C [536 °F], v = high

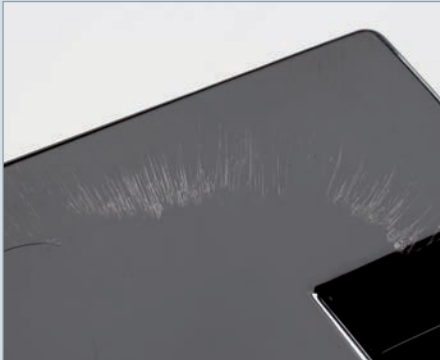
Burning streaks due to thermal degradation

Causes	Recommendations
The melt is damaged by an excessively high temperature.	<ul style="list-style-type: none"> • Measure the melt temperature and check whether it falls within the permissible processing window and, if applicable, lower the temperature of the melt in the barrel and in the hot runner. • Reduce the screw speed and/or the back pressure.
The melt is damaged by an excessively long residence time.	<ul style="list-style-type: none"> • Check whether a machine has been stopped. • Check the residence time in the barrel, if applicable, change to a smaller barrel or use a shallow-flighted screw. • Reduce the residence time in the hot runner, for instance, by selecting a shorter cycle time or by reducing the channel diameters.
The streaks are caused by high shear during the mold filling procedure.	<ul style="list-style-type: none"> • Optimize the injection speed and profile, if necessary. • Check the flow channel cross sections of the gate, of the sprue and, if applicable, of the hot runner system and enlarge them.

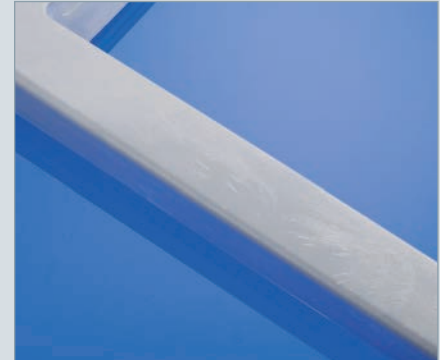
Streaks caused by thermal factors
