Injection-Molding Problems in Engineering Thermoplastics

Causes and Solutions

BASF Plastics – key to your success

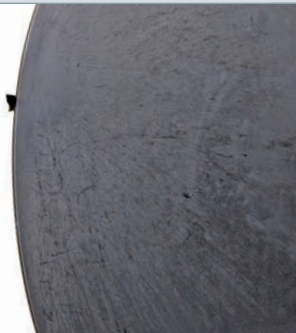
TM = 340 °C [644 °F]

Burning streaks caused by exceeding the maximum limit for the melt temperature (TM) in the case of Ultramid® T

Causes	Recommendations
The melt is damaged by an excessively high temperature.	<ul style="list-style-type: none"> • Measure the melt temperature and check whether it falls within the permissible processing window and, if applicable, lower the temperature of the melt in the barrel and in the hot runner. • Reduce the screw speed and/or the back pressure.
The melt is damaged by an excessively long residence time.	<ul style="list-style-type: none"> • Check whether a machine has been stopped. • Check the residence time in the barrel, if applicable, change to a smaller barrel or use a shallow-flighted screw. • Reduce the residence time in the hot runner, for instance, by selecting a shorter cycle time or by reducing the channel diameters.
The streaks are caused by high shear during the mold filling procedure.	<ul style="list-style-type: none"> • Optimize the injection speed and profile, if necessary. • Check the flow channel cross sections of the gate, of the sprue and, if applicable, of the hot runner system and enlarge them.

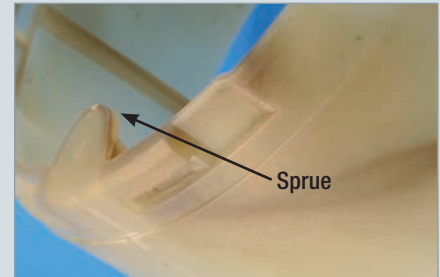
Burning streaks caused by excessively high shear in the gate (glassfiber-reinforced Ultrason®)

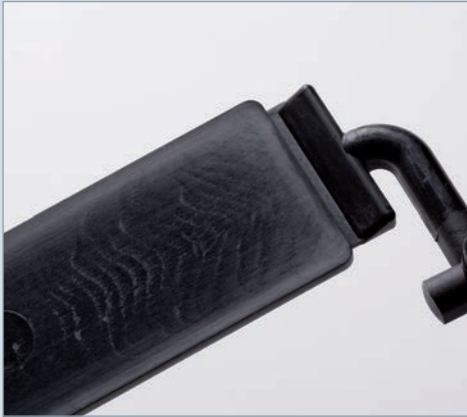
Tiger lines caused by a gate that is too small (glass-fiber-reinforced Ultramid®)

The term tiger lines refers to the alternating occurrence of glossy and matt stripes on the surface of the molded part perpendicular to the flow direction. They resemble the pattern on the coat of a tiger and are caused by a pulsating melt flow which occurs especially with thermoplastic multiphase systems (blends).

Causes	Recommendations
The cross sections of the gate, sprue and runners are too small.	<ul style="list-style-type: none"> • Increase the cross sections of the gating system and runners.
The selected cross section of the machine nozzle is too small.	<ul style="list-style-type: none"> • Install a machine nozzle with a larger bore diameter.
The thickness of the molded part wall is not sufficient.	<ul style="list-style-type: none"> • Check whether it is possible to increase the thickness of the wall of the molded part.
A large pressure loss occurs along the flow path.	<ul style="list-style-type: none"> • Increase the temperature of the melt.
The tool temperatures are too cold.	<ul style="list-style-type: none"> • Increase the tool temperature to the maximum recommended.

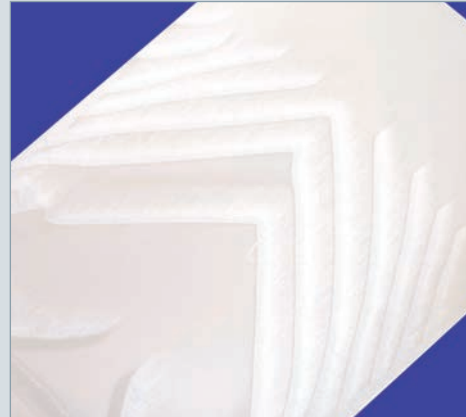
Tiger lines caused by unfavorable processing conditions (Ultraform®)

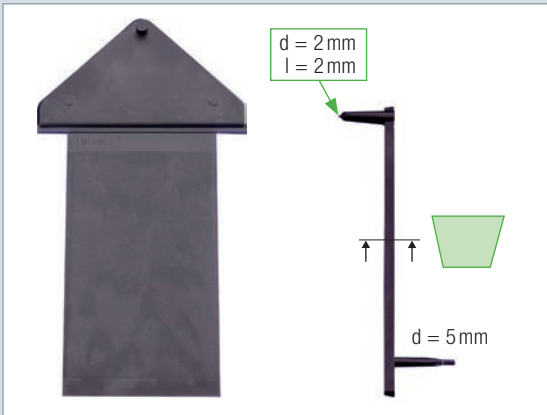
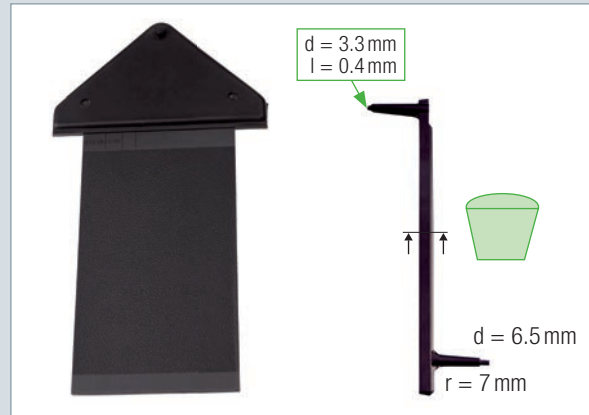
Improved molded part surface due to an improved gating system with less pressure loss

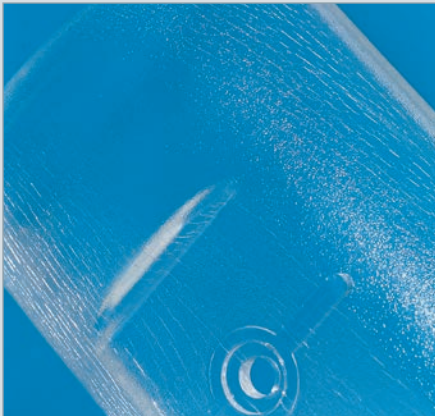
Stress cracks caused by overloading (holding pressure too high)

Causes	Recommendations
The material is overloaded because the holding pressure is too high or the mold construction is not good enough.	<ul style="list-style-type: none">• Reduce the back pressure, if applicable, set a decreasing back pressure profile.• Improve the mold construction.
The temperature selected for the mold is too low.	<ul style="list-style-type: none">• Increase the mold temperature.
Cracks are formed during ejection owing to severe external forces because of the forced removal from undercuts from the mold. This is due to not enough draft angle and the number of ejectors being insufficient, because the ejectors are positioned incorrectly.	<ul style="list-style-type: none">• Reduce the undercut or avoid it through design measures.• Improve the removal from the mold by means of larger drafts.• Optimize the ejector system.
The molecular weight of the selected product is too low; this has to be taken into consideration when aggressive solvents or chemicals are used.	<ul style="list-style-type: none">• Use a material with a higher molecular weight.

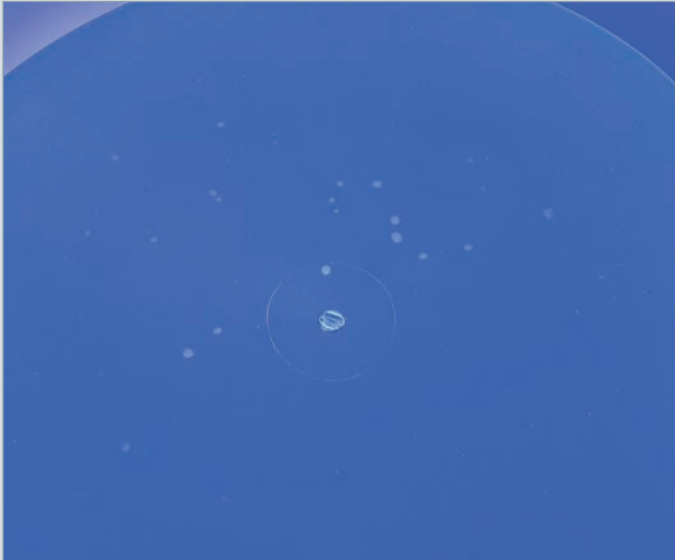
Unmolten material due to unsuitable screw geometry (Ultraform®)

Under unfavorable plasticizing conditions, unmolten material can pass through and end up in the molded part in the case of semi-crystalline thermoplastics. If the walls are thin, the unmolten material leaves a contour in the form of elevations on the surface. In the case of unreinforced, uncolored product bubbles having greater transparency can be seen.

Causes	Recommendations
Unfavorable plasticizing conditions have been selected.	<ul style="list-style-type: none"> • Select a horizontal temperature profile for the cylinder (instead of a rising profile). • Increase the melt temperature. • Raise the back pressure. • Pre-heat the granules.
The residence time of the material in the cylinder is too short.	<ul style="list-style-type: none"> • Use a machine having a larger screw diameter. • Use an injection cylinder with a longer screw.
The screw being used has an unsuitable geometry.	<ul style="list-style-type: none"> • Use a screw with a design that is appropriate for the material. Positive results have been obtained with shallow-flighted three-zone screws.

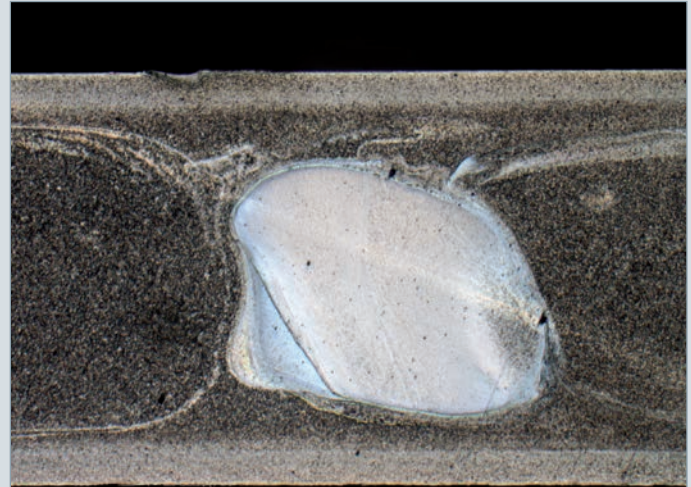
Vertical illumination/interference contrast

500 µm

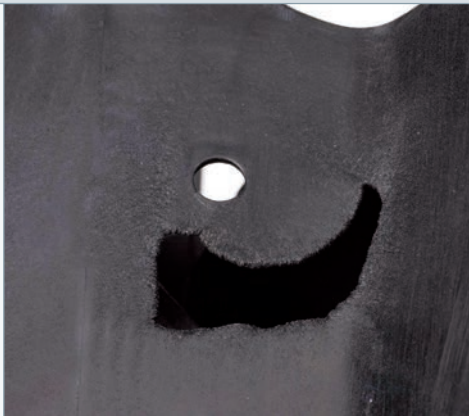
Incompletely filled
molded part due
to large pressure
loss in the gate

Incompletely filled
molded part

Causes	Recommendations
Not enough plastic melt was metered in.	<ul style="list-style-type: none"> • Increase the metering stroke.
There is no melt cushion.	<ul style="list-style-type: none"> • Check the function of the non-return valve.
The selected melt temperature and/or mold temperature are too low.	<ul style="list-style-type: none"> • Increase the melt temperature of the plastic melt and/or the mold temperature. The melt temperature should be increased first since it lowers the filling pressure. Increase the mold temperature, which, however, could also lengthen the cooling time.
The selected injection speed is too low.	<ul style="list-style-type: none"> • Increase the injection speed.
The mold is not adequately vented.	<ul style="list-style-type: none"> • Check the vents and improve the venting of the cavity if necessary.
The gating system has too much pressure loss.	<ul style="list-style-type: none"> • Enlarge the flow channel cross sections of the machine nozzle, of the runners and of the gates.

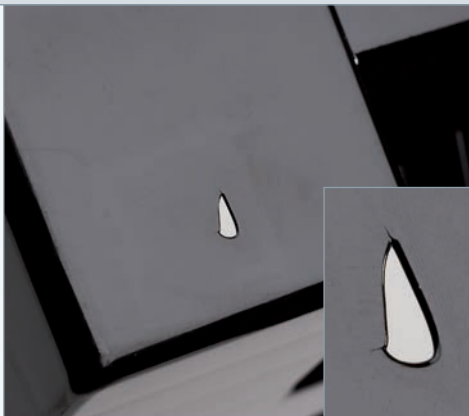
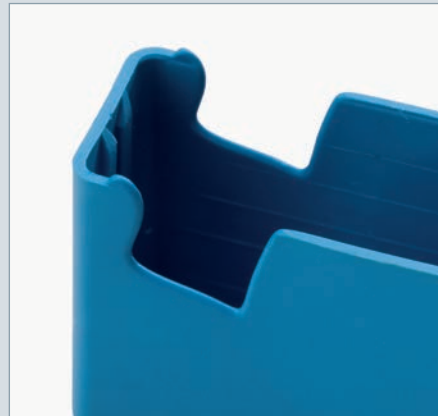
Incompletely filled
molded parts

The molded part has been designed with a wall that is too thin or the selected flow path is too long.	<ul style="list-style-type: none"> • Increase the wall thickness of the molded part. • Change the gate position or increase the number of gates. • Introduce a flow leader, if possible.
Near the gate, there is a thin-walled area of the molded part that already freezes during the mold filling procedure.	<ul style="list-style-type: none"> • Change the gate position in such a way that the area with the thin wall is the last to be filled. • Introduce an additional runner.
The flowability of the selected plastic is insufficient, even after the process parameters have been optimized.	<ul style="list-style-type: none"> • Use a material that flows more easily.

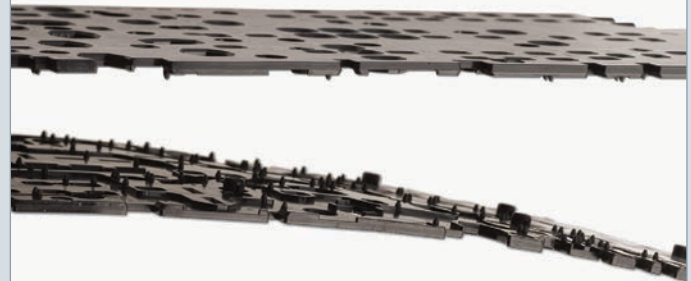
Insulating panel made of glassfiber-reinforced Ultradur®

top: molded part geometry optimized by simulation
 bottom: original situation

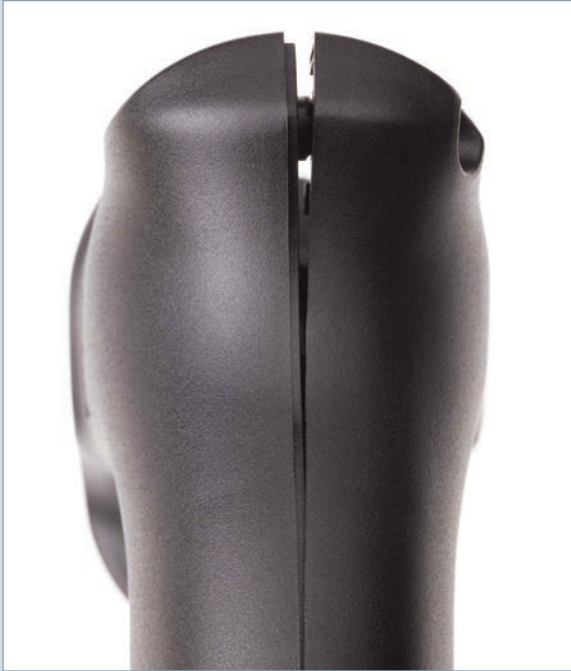
Warpage of a power drill housing made of glassfiber-reinforced Ultramid®

An unfavorable material is being used.	<ul style="list-style-type: none"> • Use low-warping materials, e.g. blends with an amorphous phase. In such products, the difference between the lengthwise and the crosswise shrinkage – which causes the warpage – is smaller.
The glass fibers of glassfiber-reinforced thermoplastics are oriented predominantly in the flow direction. Warpage occurs if the orientation of the glass fibers changes from place to place. The causes for this are, for example, deflections in the flow, orientation effects at the end of the flow path, at the weld lines and at the gates.	<p>Numerical simulation methods can be employed to predict the filling behavior and the orientation of the glass fibers. The following rules have proven advantageous for optimizing the warpage:</p> <ul style="list-style-type: none"> • Gate the molded part so as to establish a uniform flow direction (= orientation). • Gate elongated molded parts in the lengthwise direction. Symmetrical parts prove to be the best. • Avoid ribs or walls perpendicular to the flow direction. • Position the end of the flow path in corners whenever possible. • Strive to create abutting weld lines whenever possible (keep the strength in mind). • Avoid weld lines on exposed webs and place them into the corners whenever possible.

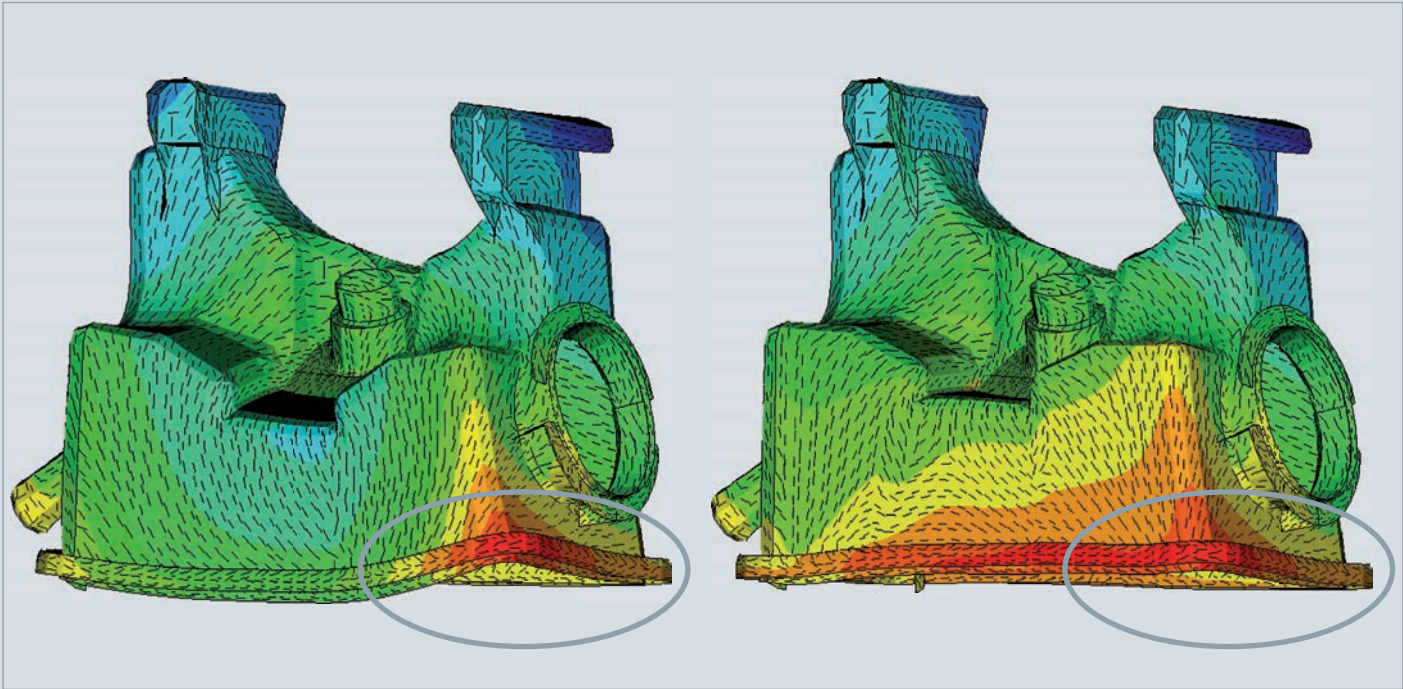
Simulation of the glass fiber orientation and warpage of a housing

left: initial situation, right: optimized geometry of the molded part

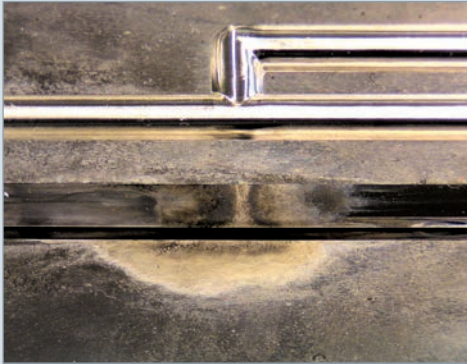
Plate-out/mold deposit in the area of a weld line due to a lack of venting

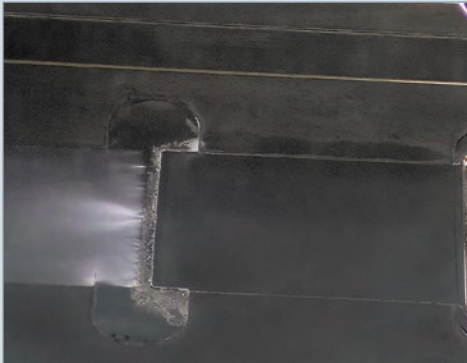
Plate-out/mold deposit at the end of the flow path due to a lack of venting

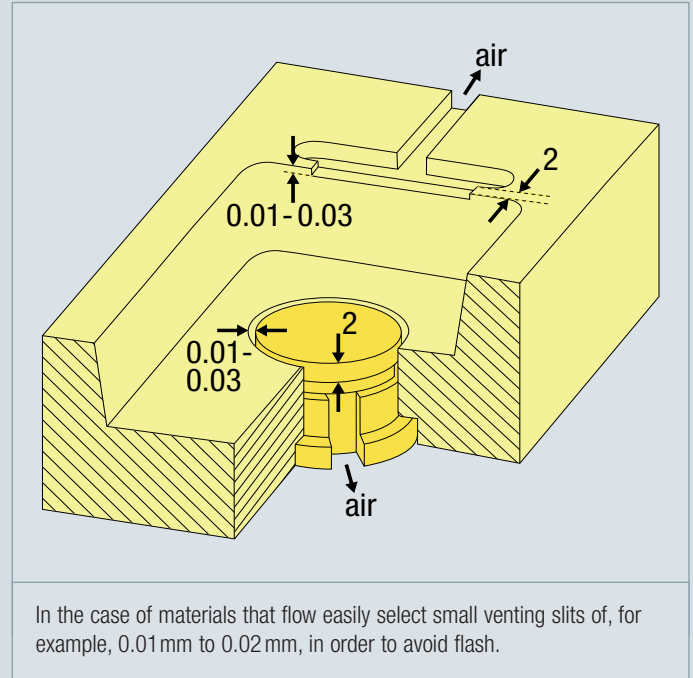
In the case of materials that flow easily select small venting slits of, for example, 0.01 mm to 0.02 mm, in order to avoid flash.

Recommendations for the design of the mold venting set-up
