Elastocoat repairs and protects against attack of sulphuric acid

Elastocoat polyurea spray coating:

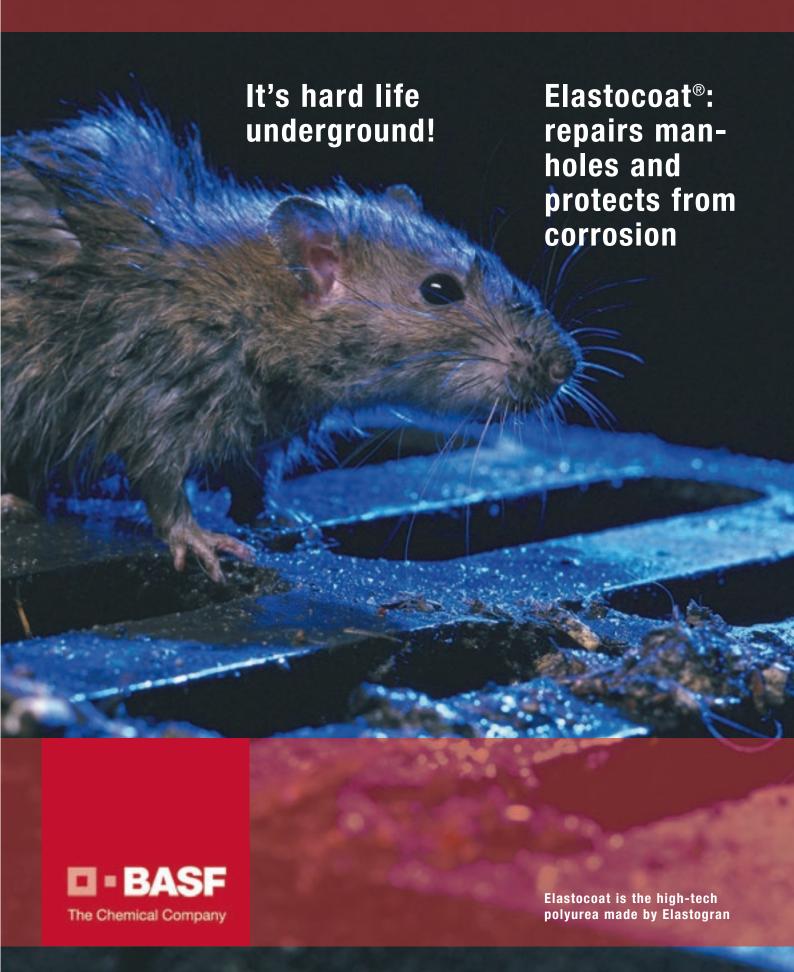
Sulphuric acid has destroyed the concrete.

Biogenic sulphuric acid generated by the bacteria Thiobacillus in gas-sealed manholes, slurry systems or biogas plants rapidly lead to heavy concrete corrosion. Washed

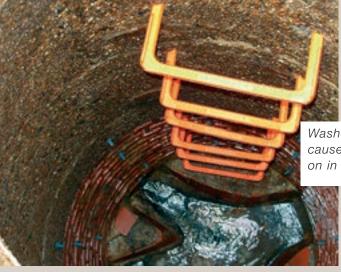
Washed concrete look caused by acid corrosion in a manhole.

concrete appearance and decomposed metal components are typical signs of damage such as corrosion, crack formation and leakage. The result can be instability of the structure as well as infiltration.

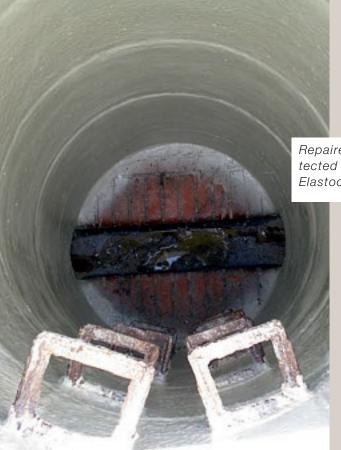
Repaired and protected long-term by Elastocoat.

Attack by acids can be stopped by the seamlessly sprayed barrier-film of 2K Polyurea Elastocoat. Elastocoat seals long-term. Curing in

seconds, the *liquid film * moulds itself to all shapes of surface achieving a trouble-free sealing of vertical surfaces. It has excellent crack-bridging properties with 400% elongation at break. The result is a high-grade and durable repair.
