# Height compensation with Elastocoast® on Holm Nordstrandischmoor (Germany)

## Case Study

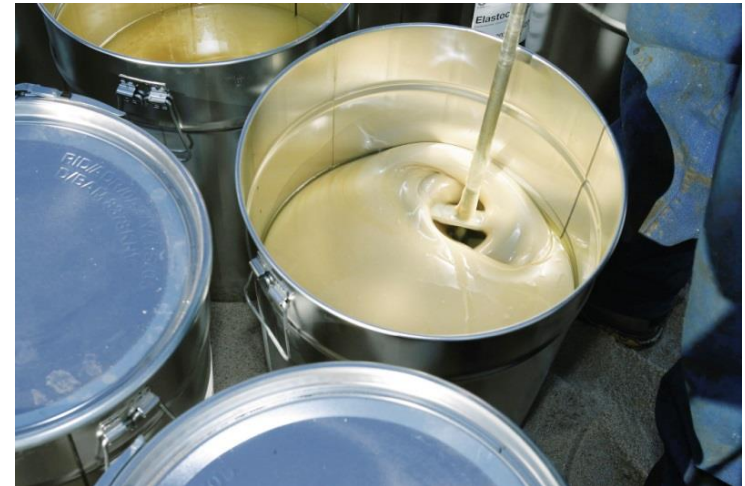
Construction: Granite gravel (40/60 mm), Elastocoast® and geotextile
